# Technical Journal

Oil consumption, “Low oil Level” or “Oil level low” in DIM

REF NO:  
TJ 24643

ISSUE DATE:  
YEAR MONTH DAY  
2013 05 15

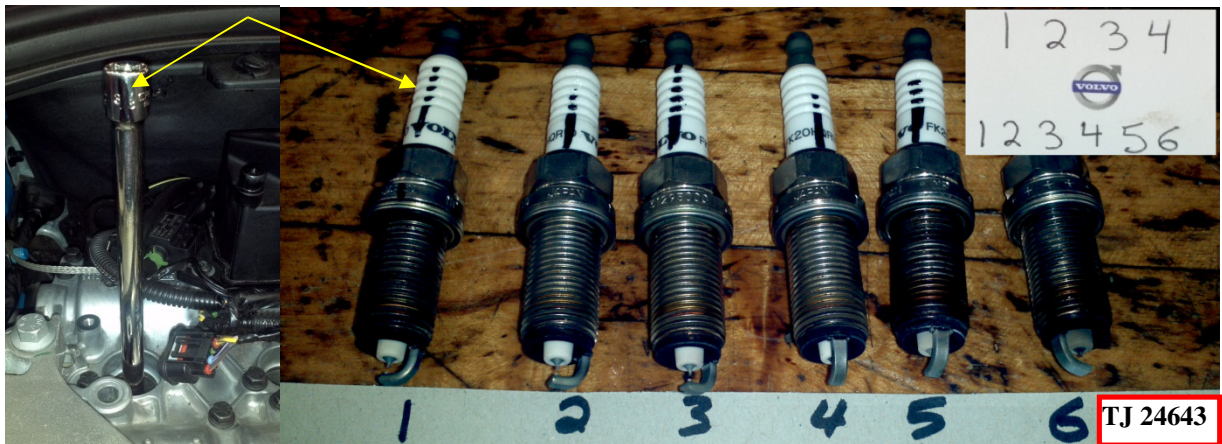
- a.) Print out DTCs using VIDA.
- b.) If the vehicle is just pulled in from the parking lot, the spark plugs may be dark due to fuel which could cause a false indication of oil consumption. Fuel deposits from one or multiple cold starts are indicated by black carbon deposits. Oil deposits can either be indicated by ash deposits which will look like brown crust on the electrodes and the ceramic or soot deposits which will look like dark coking on the electrodes and the ceramic.
- c.) Use a marker to mark the spark plug socket or socket extension being used to remove the spark plug. The mark should face the intake valves.
- d.) Once the plugs are removed, transfer that mark to the plug. This is to indicate what side of the plug was facing the intake valves when the photo of the spark plugs is submitted to Prior Approval. Take the photo with the markings facing the camera. See Photo 1.

- e.) **Spark plug soot/ash level for Prior Approval:** Level of soot/ash on plugs (0 = no soot/ash, 5 = excessive soot/ash), see Photo 1 for reference. In the example shown in Photo 1, cylinders 1-4 would have a rating of 0, cylinder 5 would have a rating of 1, and cylinder 6 would have a rating of 3. A rating of "0" would correspond to a brand new spark plug. **You will be asked to provide this information and a picture of the spark plugs when submitting the online form**

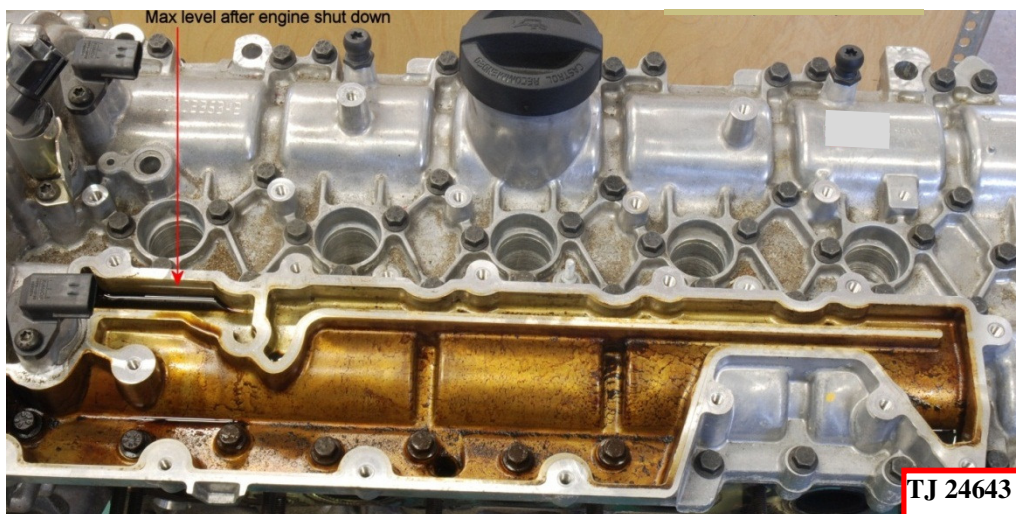
**Photo 3. Oil in the breather channel indicating a possible PCV box (oil trap) failure**

Oil in the small breather channel can be the result of multiple issues such as the engine being overfilled with oil, a defective breather box, excessive crankcase pressure or other. Oil in the small breather channel will be vented into the cylinders causing carbon/ash build-up in the cylinders starting with cylinder #6.

MY2011-2014 with Engine code 90: If the spark plug from cylinder #6 has more soot/ash than the others and the oil galley looks like that shown in Photo 3, then the oil trap is most likely at fault. Replace the oil trap, but still review the results from Steps 5 - 7. If the results from steps 5 - 7 are OK, then only replace the oil trap.\*

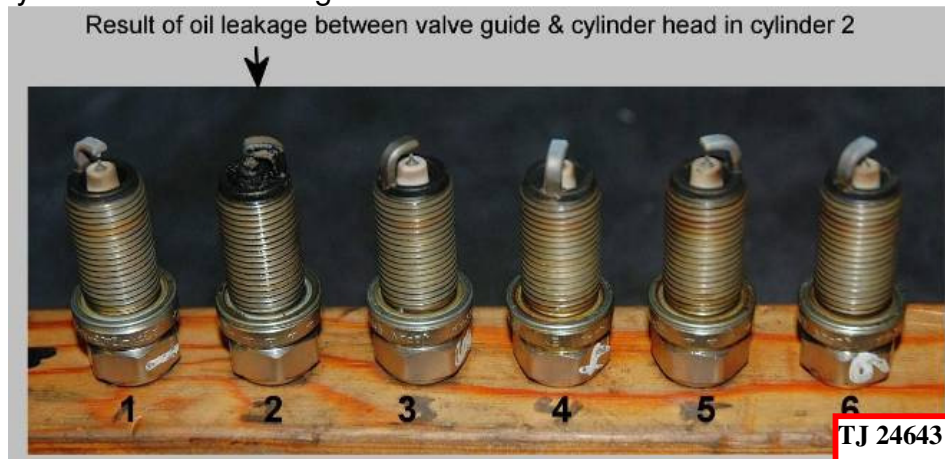
Look at the spark plugs in Photo 4 below. If the valve guide is leaking in a cylinder, the corresponding spark plug will have more soot/ash than the others. In the example in Photo 4, cylinder 2 is consuming oil.

If leakage is found on the intake or exhaust valve guides, then replace the cylinder head and add to the repair any faults found in previous steps.

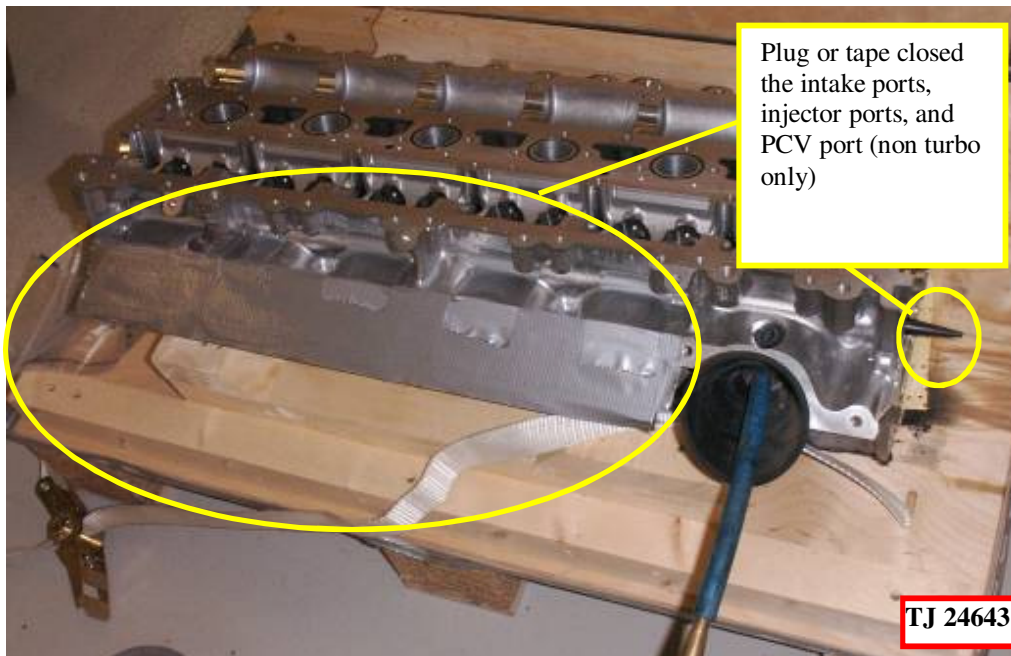
**Photo 5.** Note that the cylinder head is removed in this photo but this test should be performed on the vehicle.

**Note! Use safety glasses!** Remove the valve tappets. Plug all but one intake port, all injector ports, and the PCV inlet. On a turbo engine, the PCV inlet will have a check valve. If air is coming from that valve in the test, block it with tape. Starting with the intake port that corresponds to the spark plug with the most soot/ash, apply air pressure to one intake port at a time using a plug similar to those found on emissions testers. See Photos 5 and 6. Look at the base of the valve spring and check for ripples or bubbling in the ATF as you apply light air pressure.

If oil is found in the galley shown in Photo 5 on an engine code other than 90, then mention this on the prior approval form and the response from prior approval will specify what to do next.

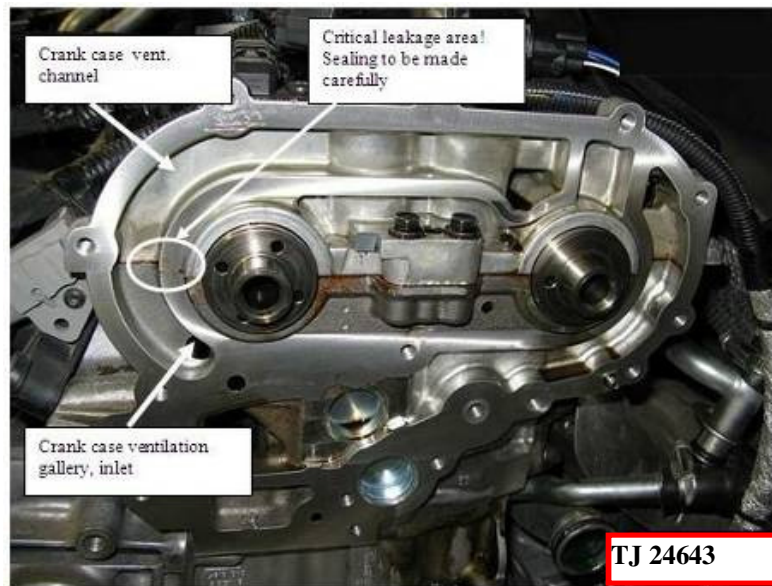
Photo 7. For reference only, not a valid check

If spark plugs in cylinder 6 & 5 have more soot than the other plugs and the engine is built before engine production date 15041000001 (DDMMYYxxxxx), then remove the cam cover and inspect the sealing surface. Refer to Photos 7 and 8 below.

If the sealing surface is discolored by oil as shown in the photos, it is most likely that there is a leak between the cam cover and the cylinder head. If this is the case, reseal the cam cover and add to the repair any faults found in previous steps. Be sure to check the expiration date of the sealant bottle before use.

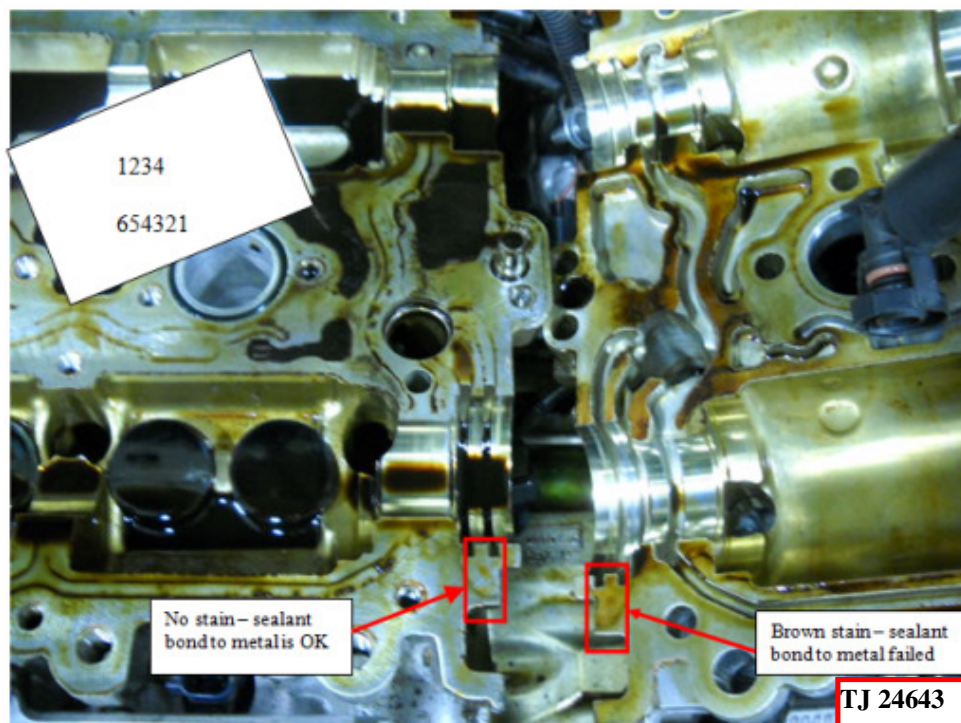
Photo 8. Check method for cam cover sealing surface. Note the placard with retailer number and chassis number is required upon submission of this photo to prior approval.

The cam cover seal was improved at engine production date 15041000001 (DDMMYYxxxxx). The production date, in this case is April 15, 2010. The engine serial number can be found using VIDA "Vehicle Details".
