## Retailer Technical Journal 14545

### Water intrusion into passenger compartment S40 / V50

Date 10-7-2008

Volvo Cars of North America, LLC  
Technical Support

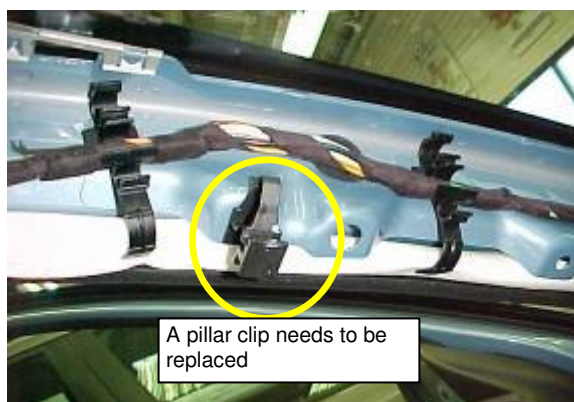
Remove the retaining clip, shown here and replace when trim the panel is reinstalled.

**Note:** windscreen removed in these pictures to identify concern. There is no need to remove the windscreen for this repair.

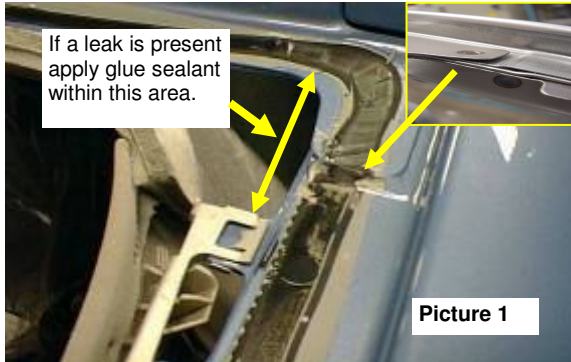
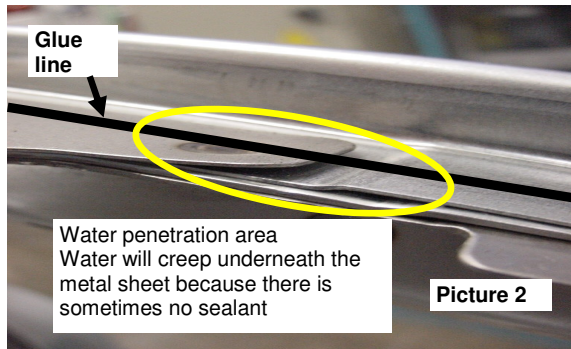
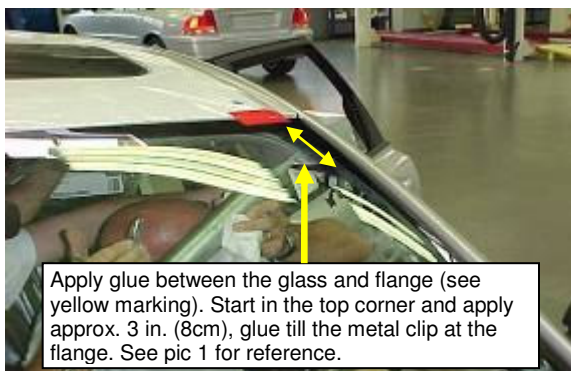
From inside the vehicle be sure no water is entering the area. If so, locate the exact spot (pictures 1 & 2 might give you a hint of a possible location)

- dry the area completely with compressed air
- apply sealing compound (PN 1161767) by use of a generic sealant gun. (insert a small spacer between the headliner and flange in the top corner for better access)
- ensure the application of sufficient amount of sealant, remove excess sealant with a 'wet' finger or spatula
- after the sealant has hardened (approx 6 hrs), check the water tightness of the area again.

- install a new retaining clip (PN 30673305) to both A pillars
- install both A pillar trims

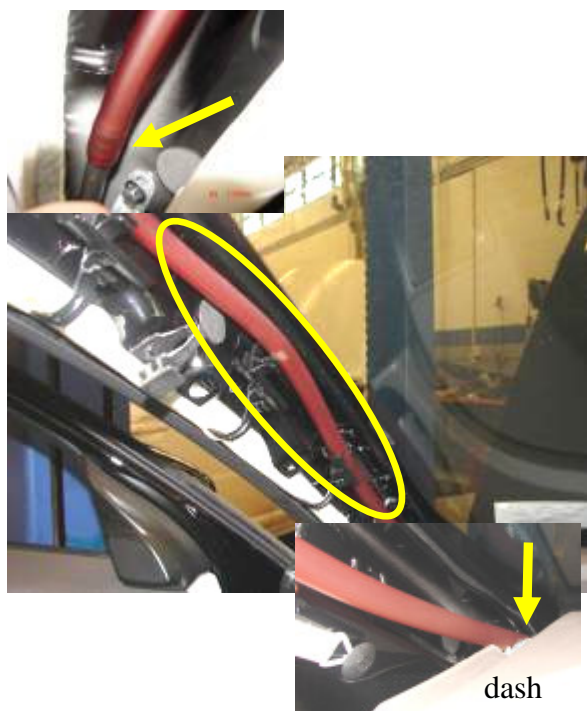
Inspect the installation, location and condition of the drain. It should look the same as the one shown here.

Although difficult to see, feel with your hand and ensure the hose is installed in the sound trap.

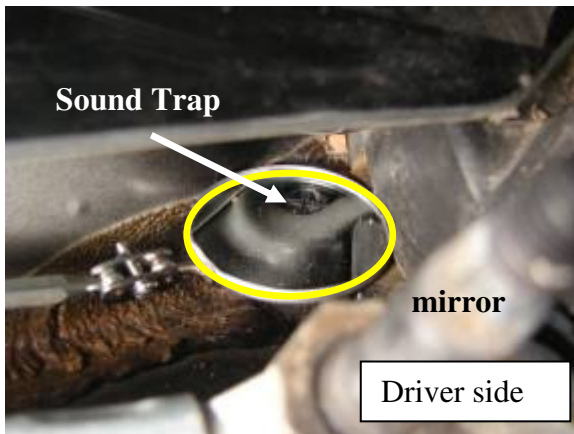
At the front - corner area of the sunroof opening of the side with the water intrusion: have helper pour water into the sunroof drain area and observe the water traveling thought the hose.

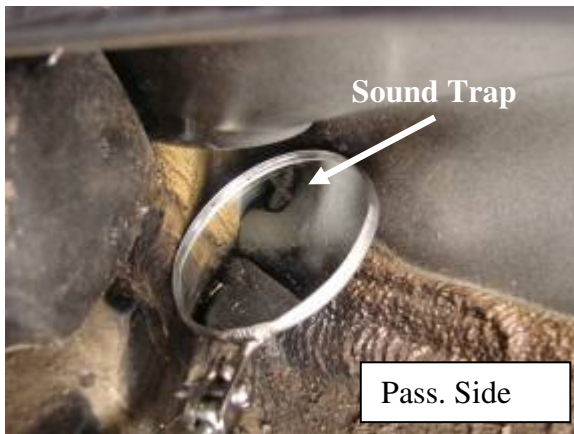
With a mirror inspect the sound trap exit condition and water flow.

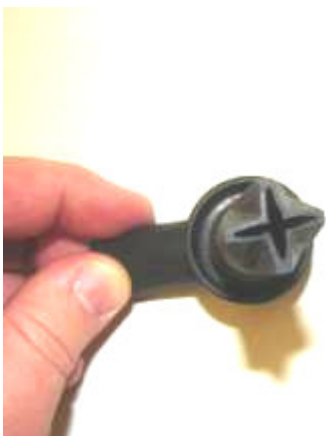
Note the shape and location of the sound trap.

You can place your finger(s) on the tip of the sound trap. It should be slightly higher then the opening in the sheet metal.

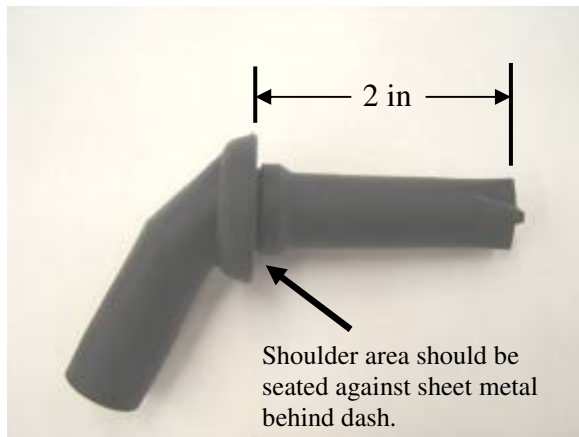
View of the sound trap exit.

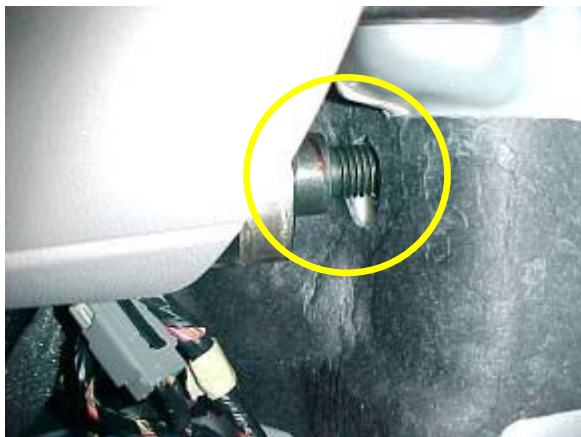
Be sure the marked area is tested thoroughly.

**NOTE:** Only driver side is shown. However the same issue can occur at either the driver or passenger sides.

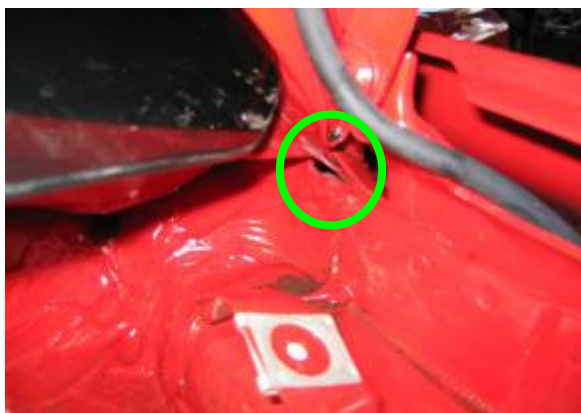
With the water running; check if water enters either around the instrument panel mounting bolt or the area directly surrounding.

The water leak can also be confirmed by checking the A pillar area where the door harness is located (see pictures in step 3).

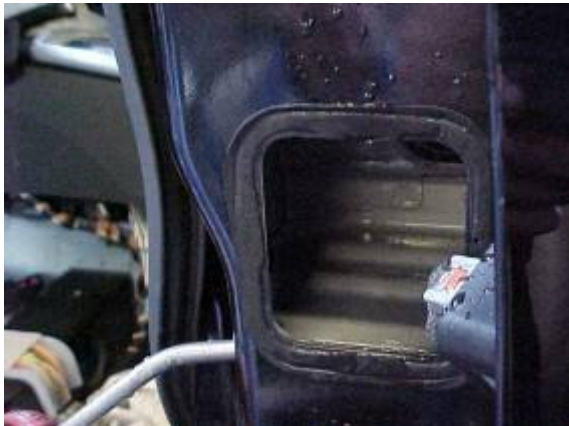
With the door removed you will have access to inspect the inside of the A pillar area.

Remove the water from the A pillar with compressed air.

Be sure to insert the nozzle of the air gun in the gaps between the A pillar and brackets as shown.

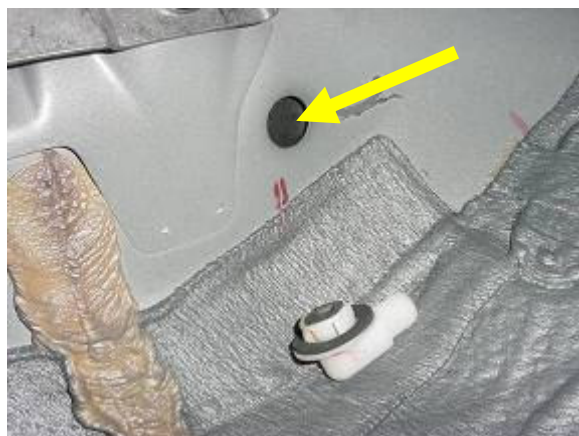
**DESCRIPTION:** It has been discovered that the air conditioning evaporator drain can become blocked by the sound insulation material below the floor panel. This may cause the water in the climate system housing to overflow onto the passenger compartment floor.

Remove the climate housing drain and inspect to ensure the sound insulation material is not too close to drain.

**NOTE:** Water on this material causes swelling

The minimum distance between the end of the drain and the sound proof insulation should be 1/4 inch (5.8 mm).

**NOTE:** When reinstalling the drain ensure there are no kinks in the hose and the assembly is fitted correctly.

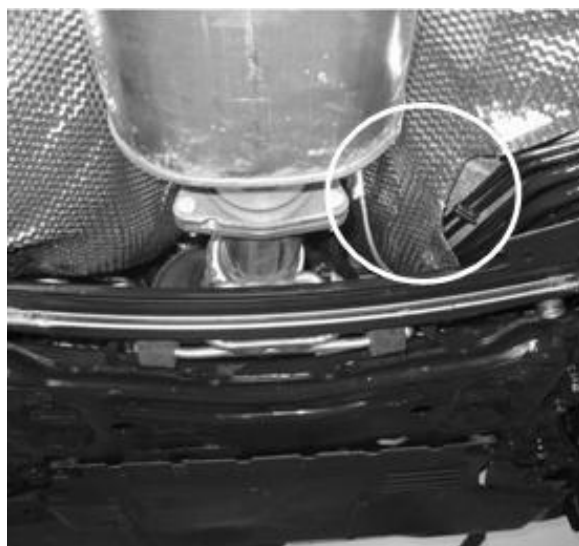
The drain for the climate unit is located in this area.

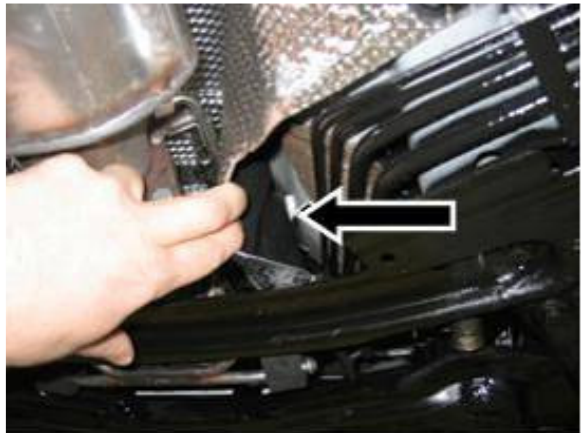
Carefully bend out the heat shield.

**NOTE:** the arrow indicates the location drainage outlet.

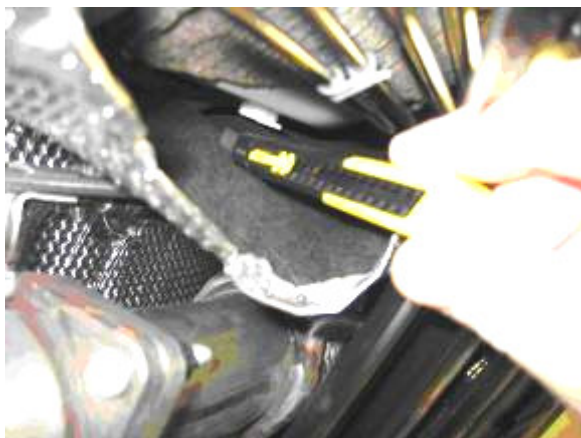
With a knife; slice the insulation in the area of the drain.

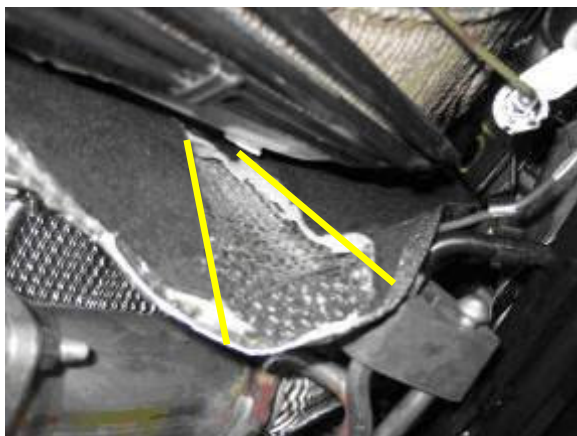
Once sliced; remove (scrape) the sound insulation from the area of the drain so that drainage is not restricted.

Carefully reposition the heat shield and reinstall the cross member per VIDA.
