## ACDelco 24228787 AW55 Valve Body Replacement Part for use in Volvo Transmission

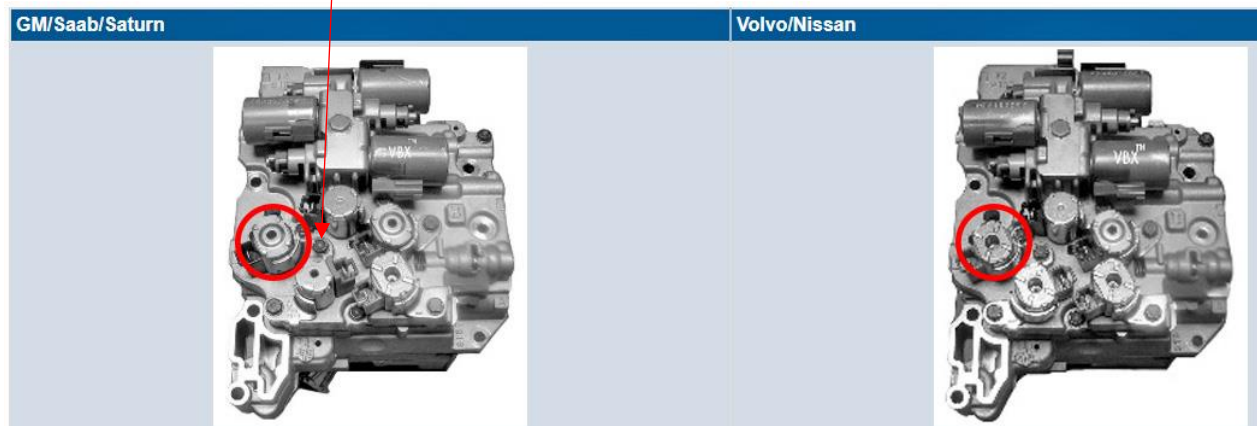
### S2 solenoid swap required

- Use original Volvo valve body S2 shift solenoid and replace the S2 solenoid on the new GM valve body ACDelco 24228787
  - One M5 bolt to remove, re-torque to 7 N-m or 62 inch-lb.
  - O-ring between solenoid and valve body
  - GM version S2 solenoid different type(ID by dome top) than Volvo (flat top) S2 solenoid so swap required
- Use new O-ring from GM S2 solenoid and replace O-ring on original Volvo S2 solenoid

Required for Volvo compatibility when using AC Delco replacement Valve body

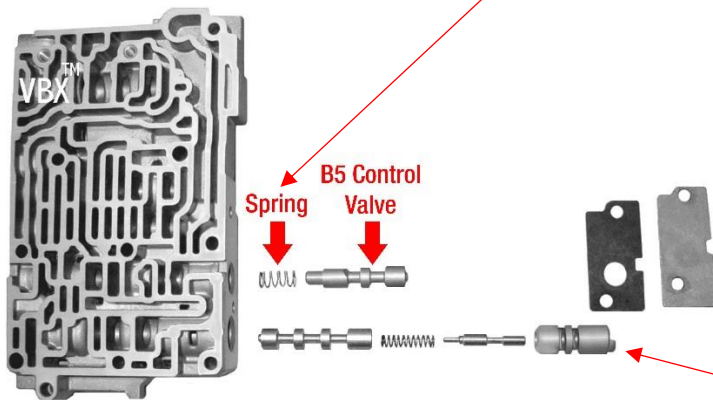
## B5 Control Valve Spring Removal

- Typically this spring needs to be removed from new AC Delco valve body for Volvo compatibility.
  - Check if the original Volvo valve body has the B5 spring or not, early version valve body won't have the spring
  - Match original B5 configuration; either keep or remove B5 Control Valve Spring to match original Volvo valve body
  - To check: locate plate with two bolts on the valve body left side, remove plate, pull out B5 control valve and check for spring, cover plate bolt torque 7 N-m or 62 inch lb.
  - Use caution with cover plate gasket, hard, brittle material, easily cracked if bent

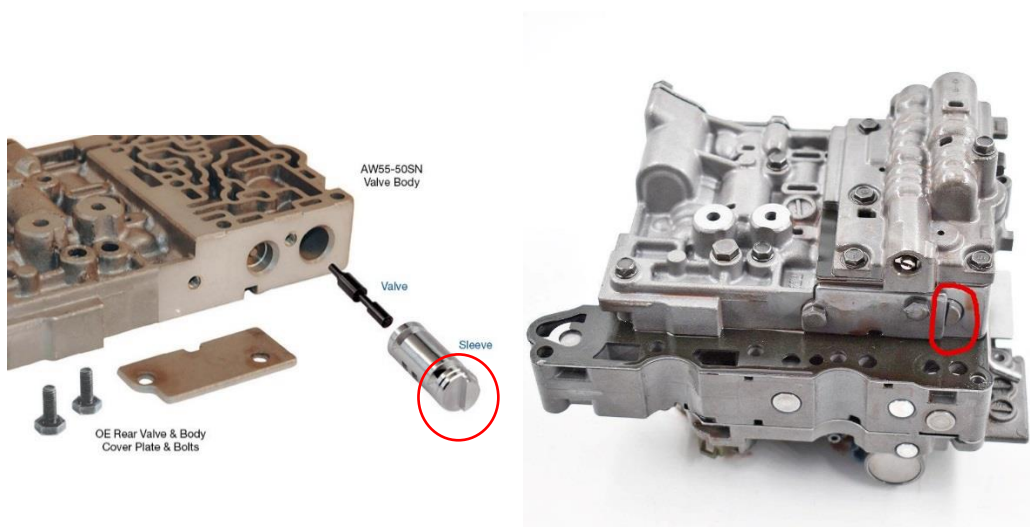
On reassembly of cover plate, pay careful attention to Lockup Relay Control Valve sleeve orientation, note the step on the end of the sleeve, raised portion edge step must align with edge of plate.

This sleeve is spring loaded and can be pressed into the bore with the step rotated under the plate incorrectly. This holds the sleeve deeper in the bore and this will cause TCC lockup problems with a P0740 error. Very important to make certain the raised half of the sleeve end is not under the plate during reassembly. The sleeve end step edge should align with the edge of the plate as shown.

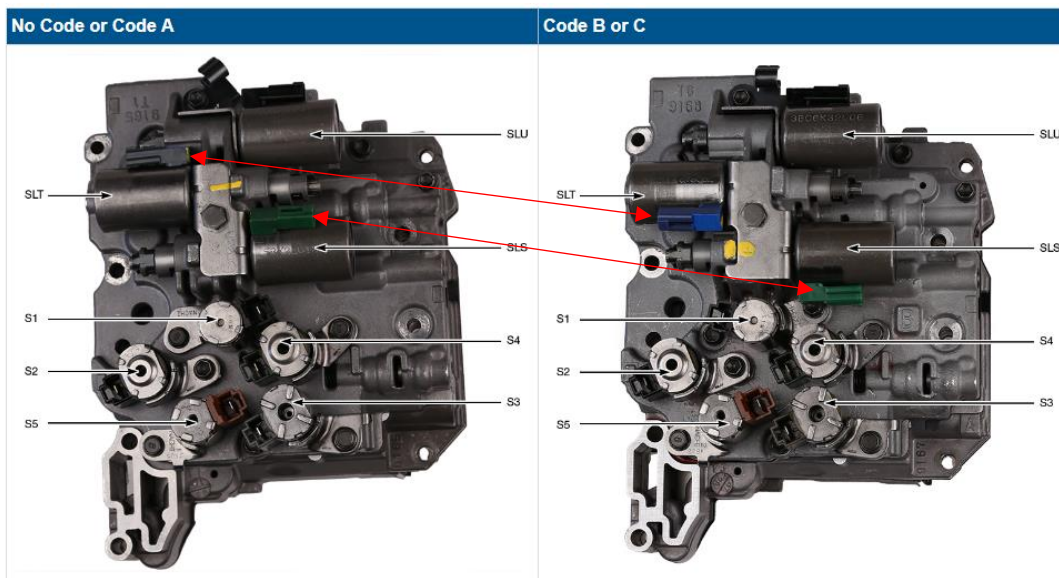
Difference in SLT and SLS solenoid connector location between early (connectors top location) and later revision valve body (connectors bottom location) and why wires need to be lengthened with newer revision valve body or wiring harness replaced

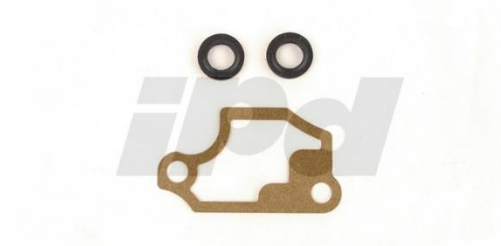
Volvo valve body gasket kit, Volvo part number 274470, available at IPDusa, Fcpeuro, Amazon...

The two sealing rings between the valve body and transmission case should be replaced.

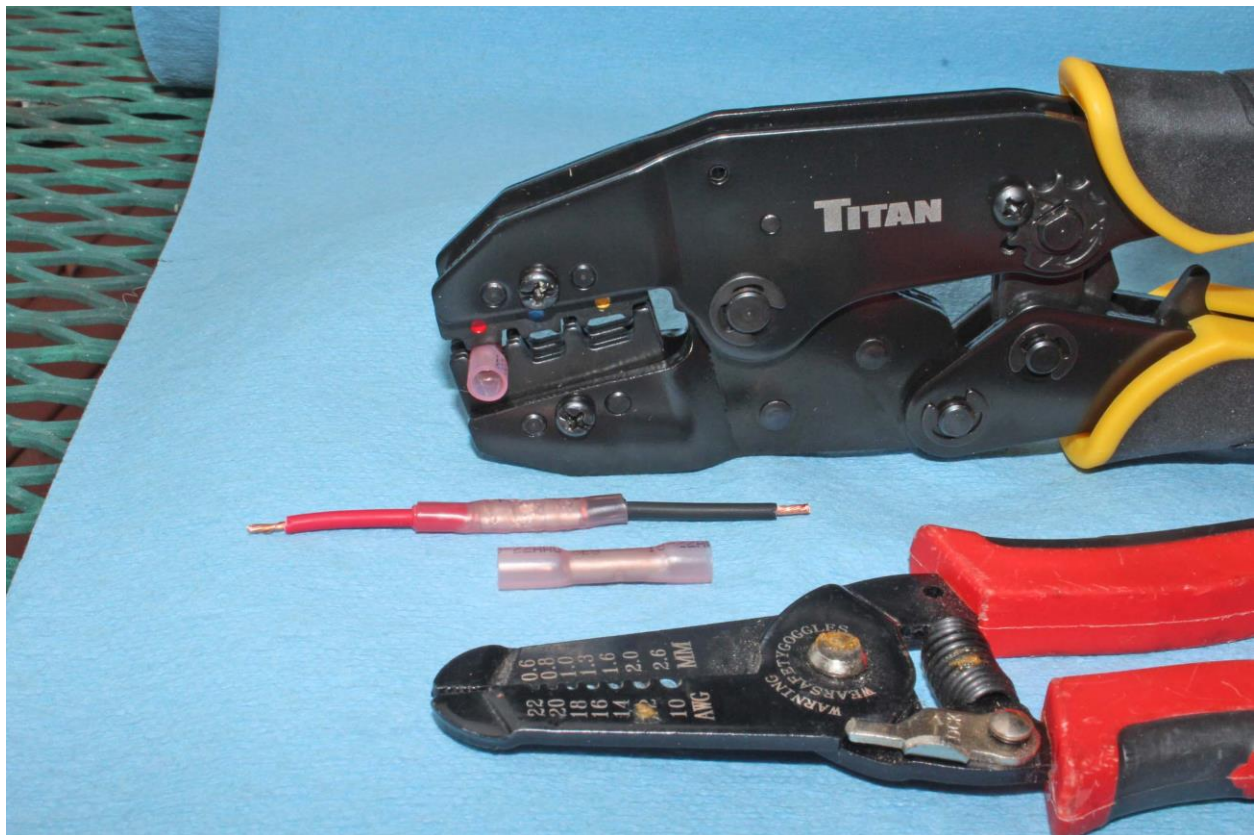
Tools needed for crimp type wire splicing using insulated butt connectors

Titan Tool 11477 ~\$25, wire strippers ~\$12

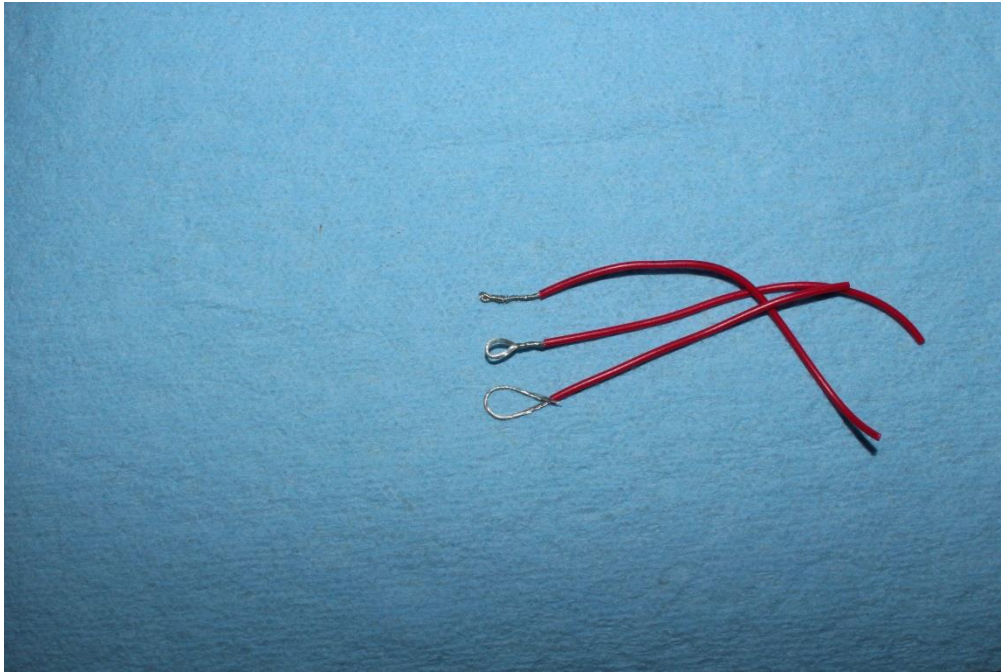
For small gauge wire such as the wire gauge to the solenoids and if there's any question about the quality of the crimp connection the wire ends can be looped and twisted to increase wire diameter and provide a tighter crimp connection
