# XC90 2007 Voltage Regulator In-situ Replacement

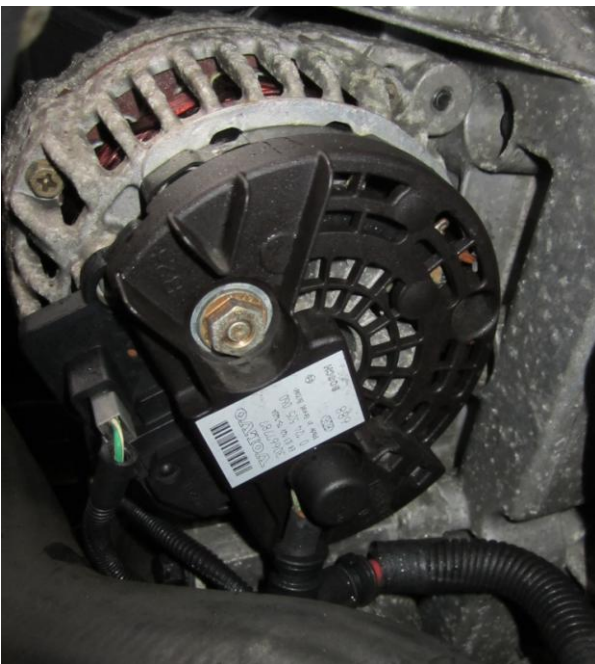
This is what your XC90 should look like before starting.

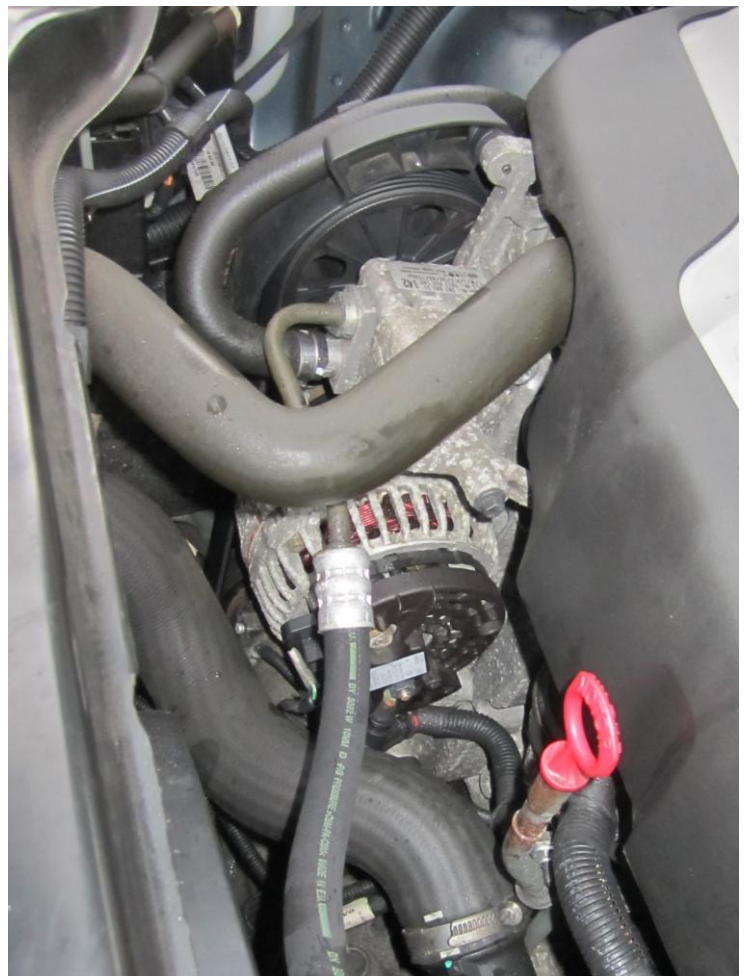
## Step One:

Disconnect the cables; there are two cables, the main 12V lead and the control cable. To remove the control cable; simply pull gently. To remove the 12V line, first remove the plastic cap, then using a 13mm socket (I needed to use a universal joint on the socket set) undo the nut. Remove the 12v cable from the alternator.

Then using the same 13mm socket remove the second nut on the bolt that held the 12v cable

Then using the same 13mm socket remove the stand-alone nut.

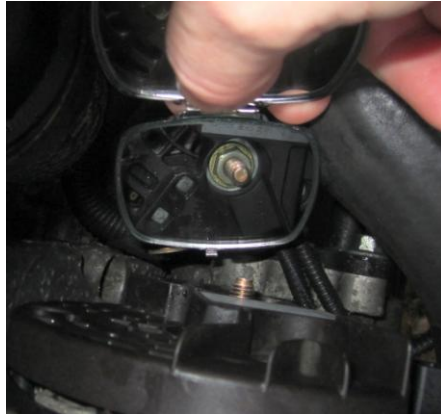
12V Lead removed

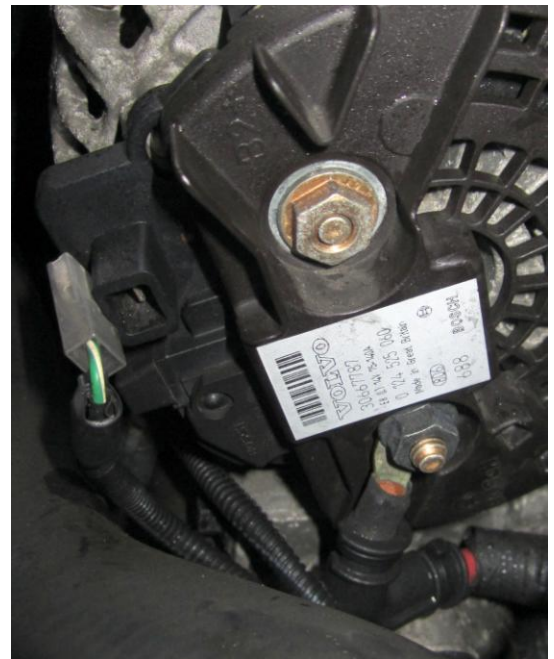
Control Cable Removed

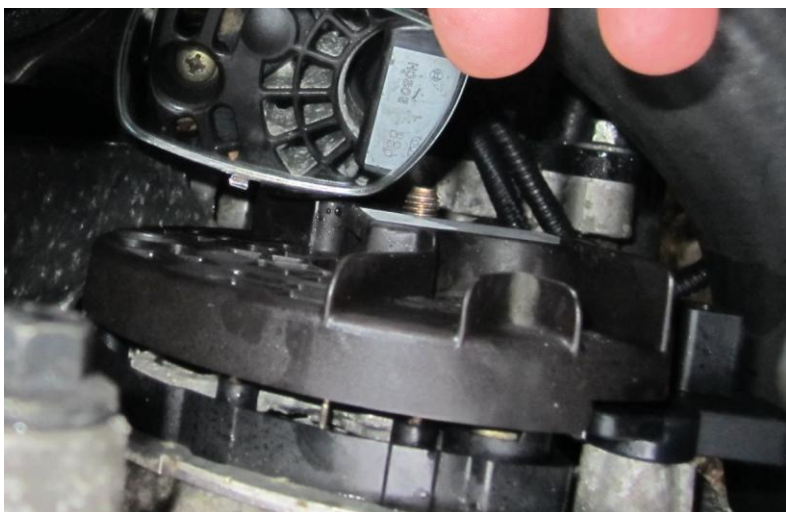
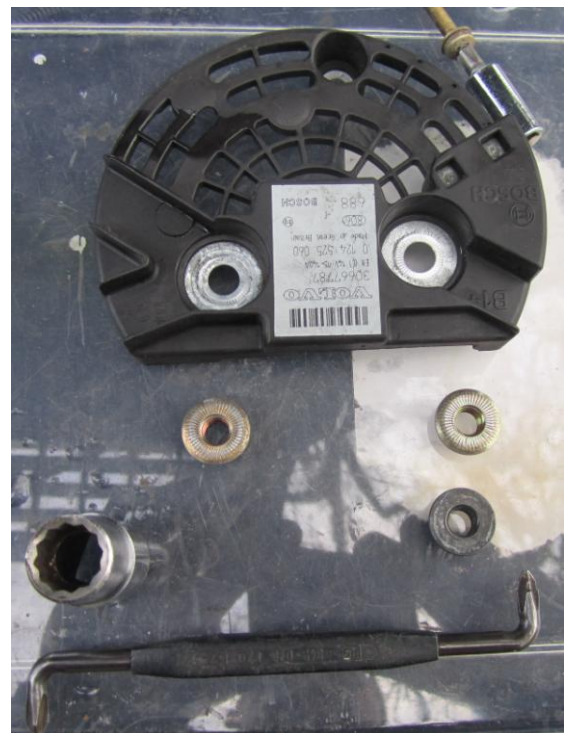
The cover can then be removed. And looks like this;

Remove the bolt holding the cover in place using a cross-head screwdriver bit, using a right-angle screwdriver and/or a ratchet screwdriver (or both).

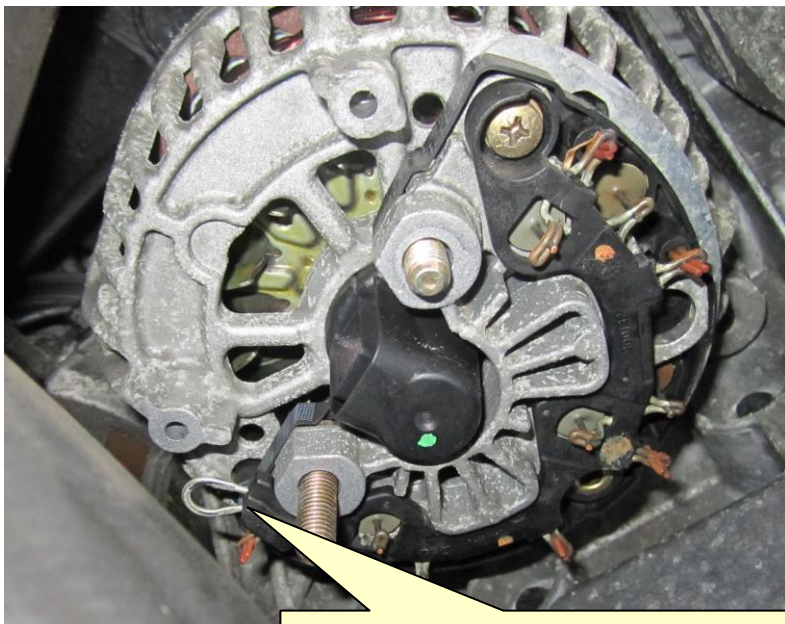
This is what the alternator now looks like.

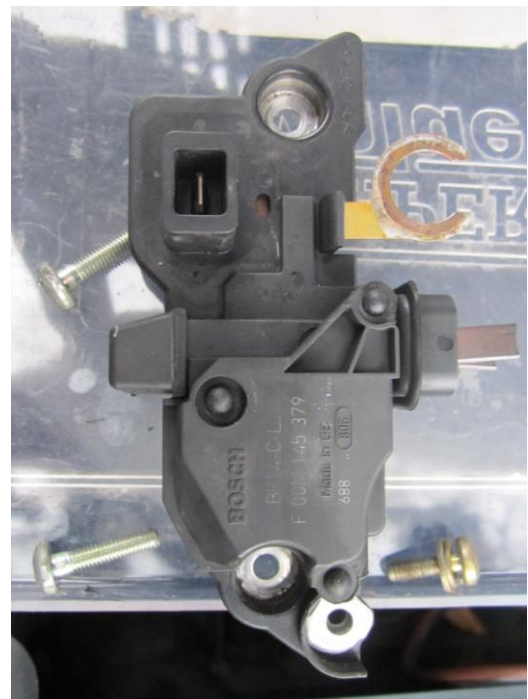
Note the voltage regulator goes under the electrical connecting wire when refitting

It's obvious, but replacement is the reverse of removal!
