873: Climate unit, B6304T2, L.H.D

S80 (07-), 2008, B6304T2, TF-80SC AWD, L.H.D

**873: Climate unit, B6304T2, L.H.D****Operation number:**  
87306-2**Blower motor  
passenger  
compartment**

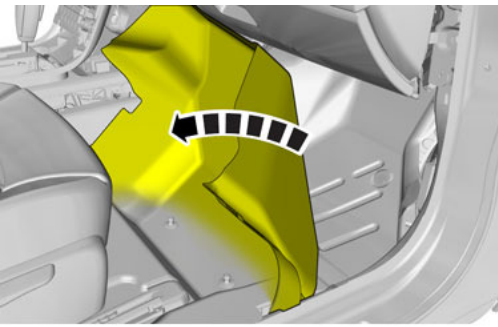
Remove control module  
relay box passenger  
compartment

Refer to: Control  
module relay box  
passenger compartment

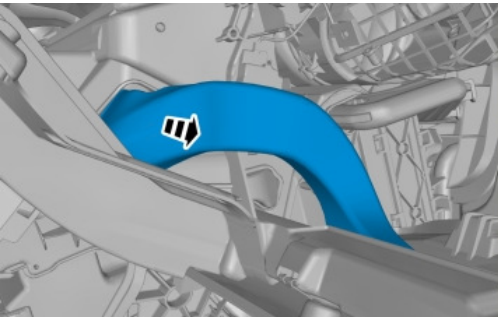
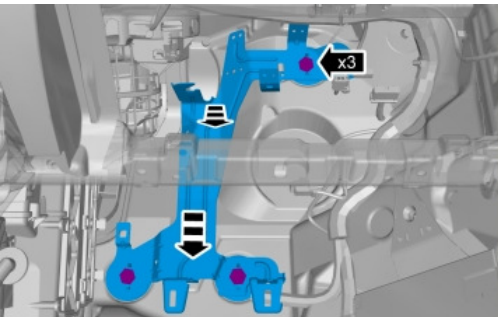
**Torque:** M8, 24 Nm

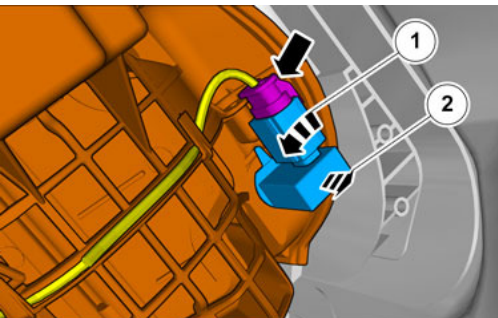
**Vehicles with air  
quality sensor**

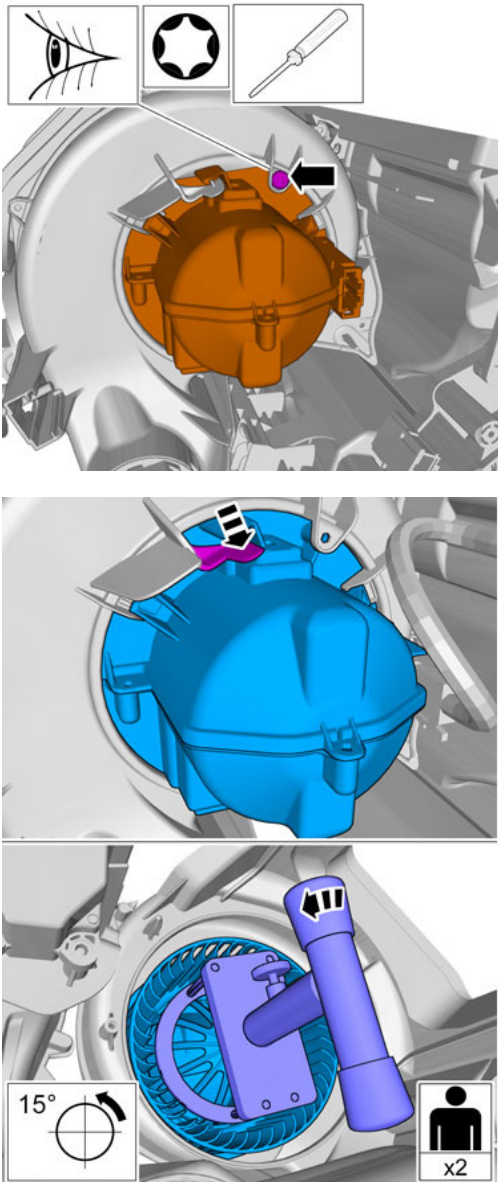
**Caution!** Take extra care when handling the component.

Special Tool: 999 7284

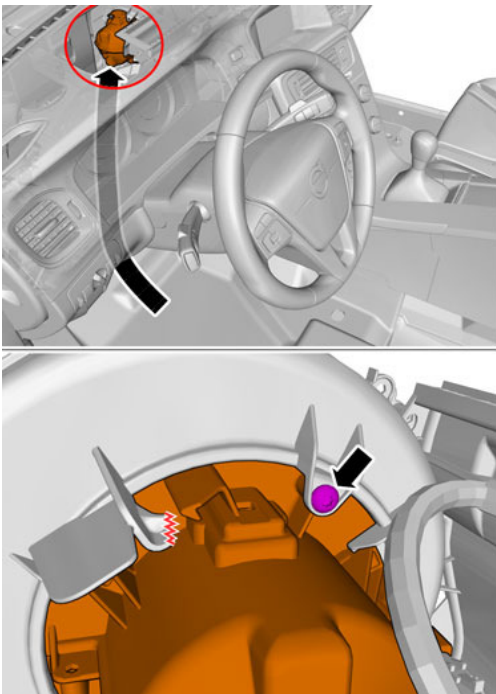
**Caution!** Make sure that the blower motor and fan assembly is placed on the bench with the fan pointing upwards.

**Note!** Replace with a screw if necessary.

If necessary

To install, reverse the removal procedure.
