Bushing inspection and replacement

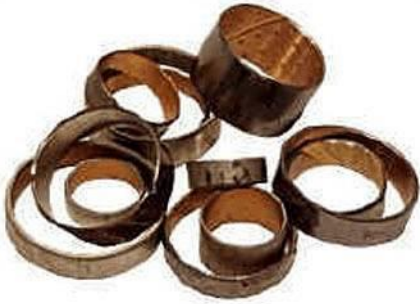
Busing kit from Oregon Performance Transmissions

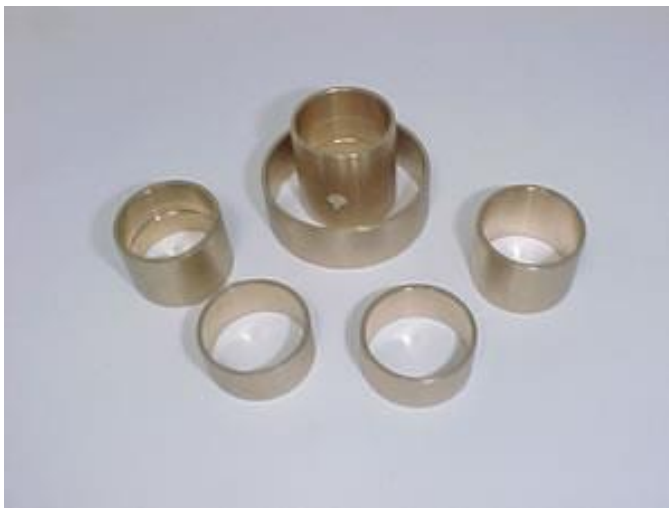
Omega Machine bushing kit, partial

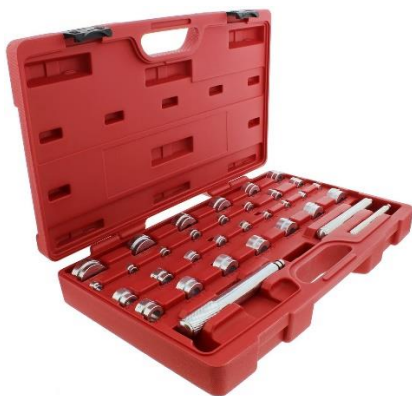
ABN Driver kit

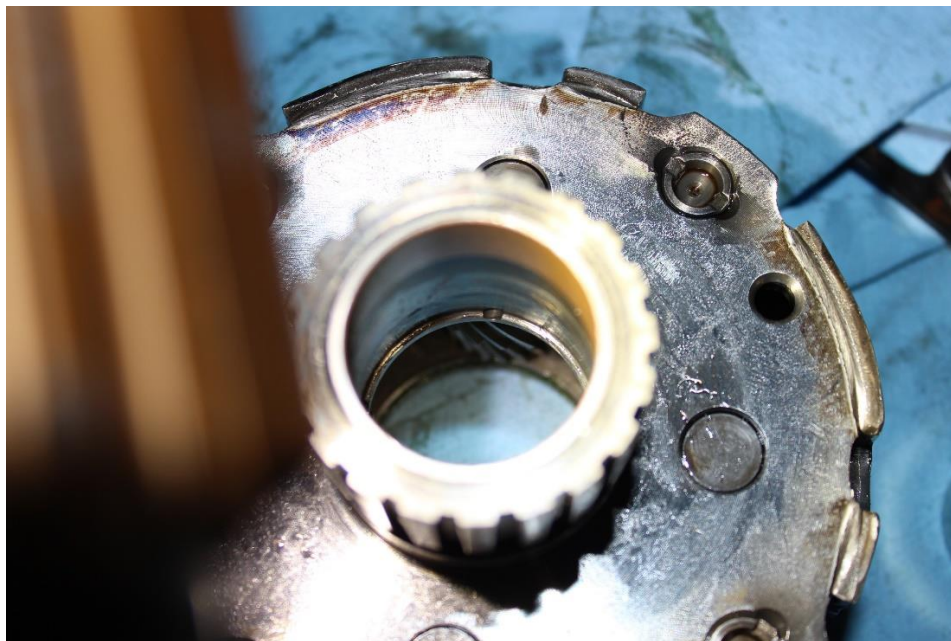
With the rear planet and if using the snap ring method to drive out bushings it's important to note there's a support edge lip for the bushing where you can't keep driving the snap rings to remove this bushing. In the photo you can see this edge lip that supports the bushing. You can drive out the bushing most of the way and pull it out the remaining way but don't drive the snap rings against this edge lip. This edge lip is there to provide a space between the bushing and planet for oil flow to the planet gears.

Bushings removed, support edge visible, important to not drive snap rings against this edge lip. Drive out bushing most of the way then pull out bushing.

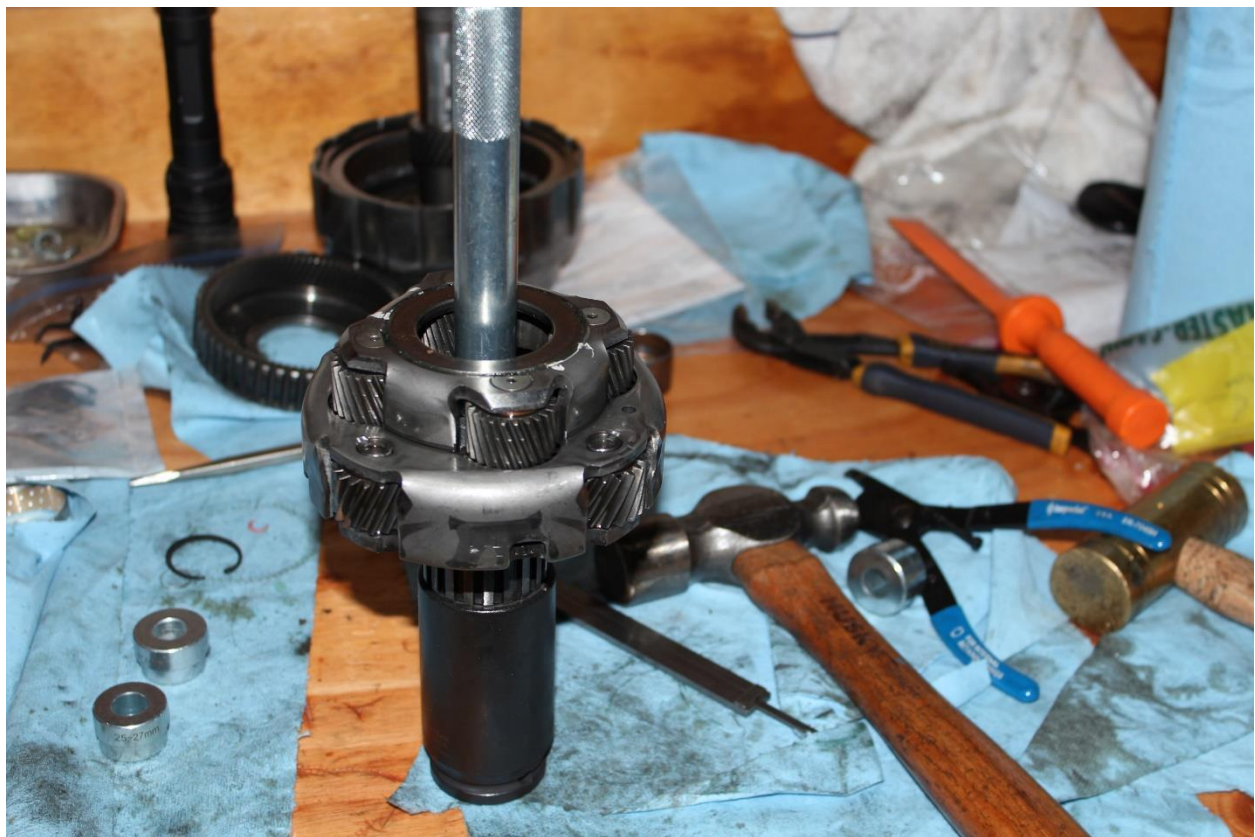
Driver in planet with receiver socket on bottom.

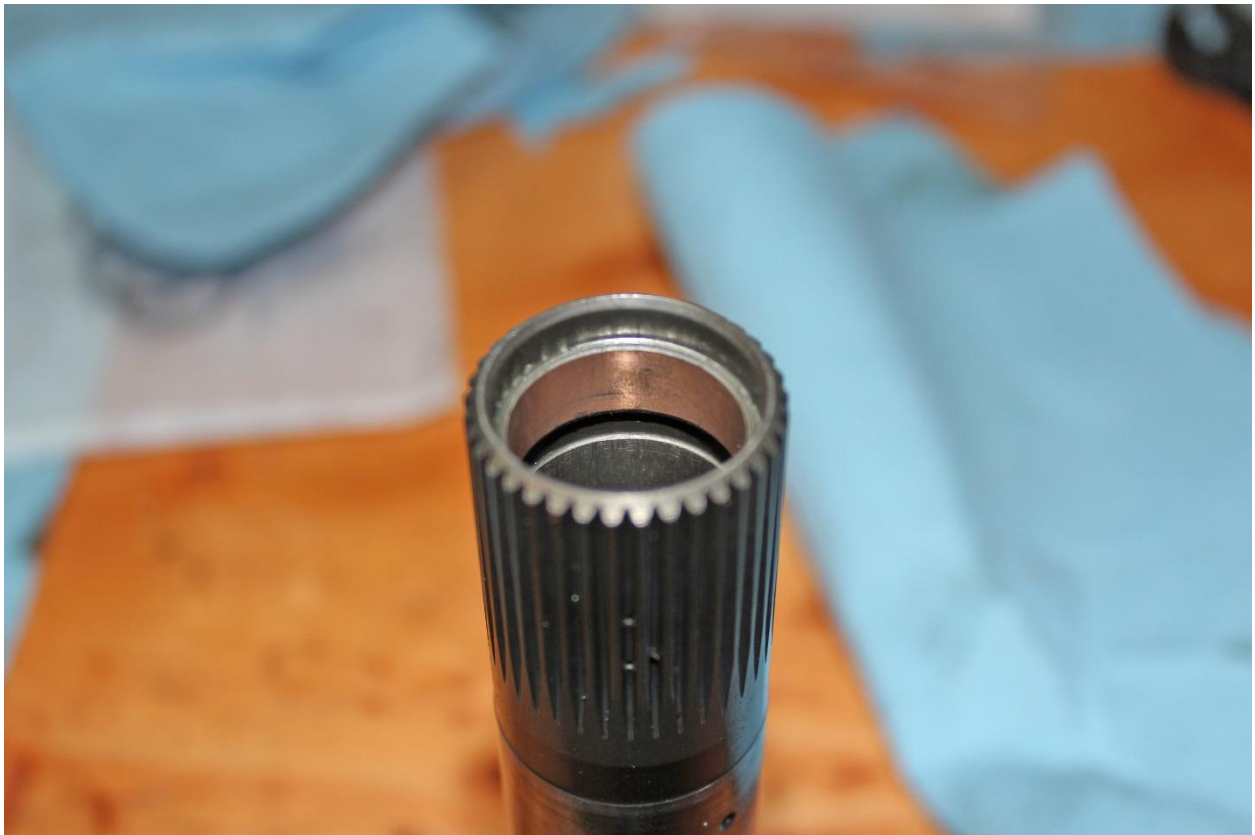
The 2<sup>nd</sup> gear shaft has two bushings and one bushing needs to be recessed some for a bearing thrust washer that protrudes into the shaft a short distance. The bushing needs to be deep enough not to interfere with this thrust washer. There's also an oiling hole that could be covered up if the bushing is driven in too deep.

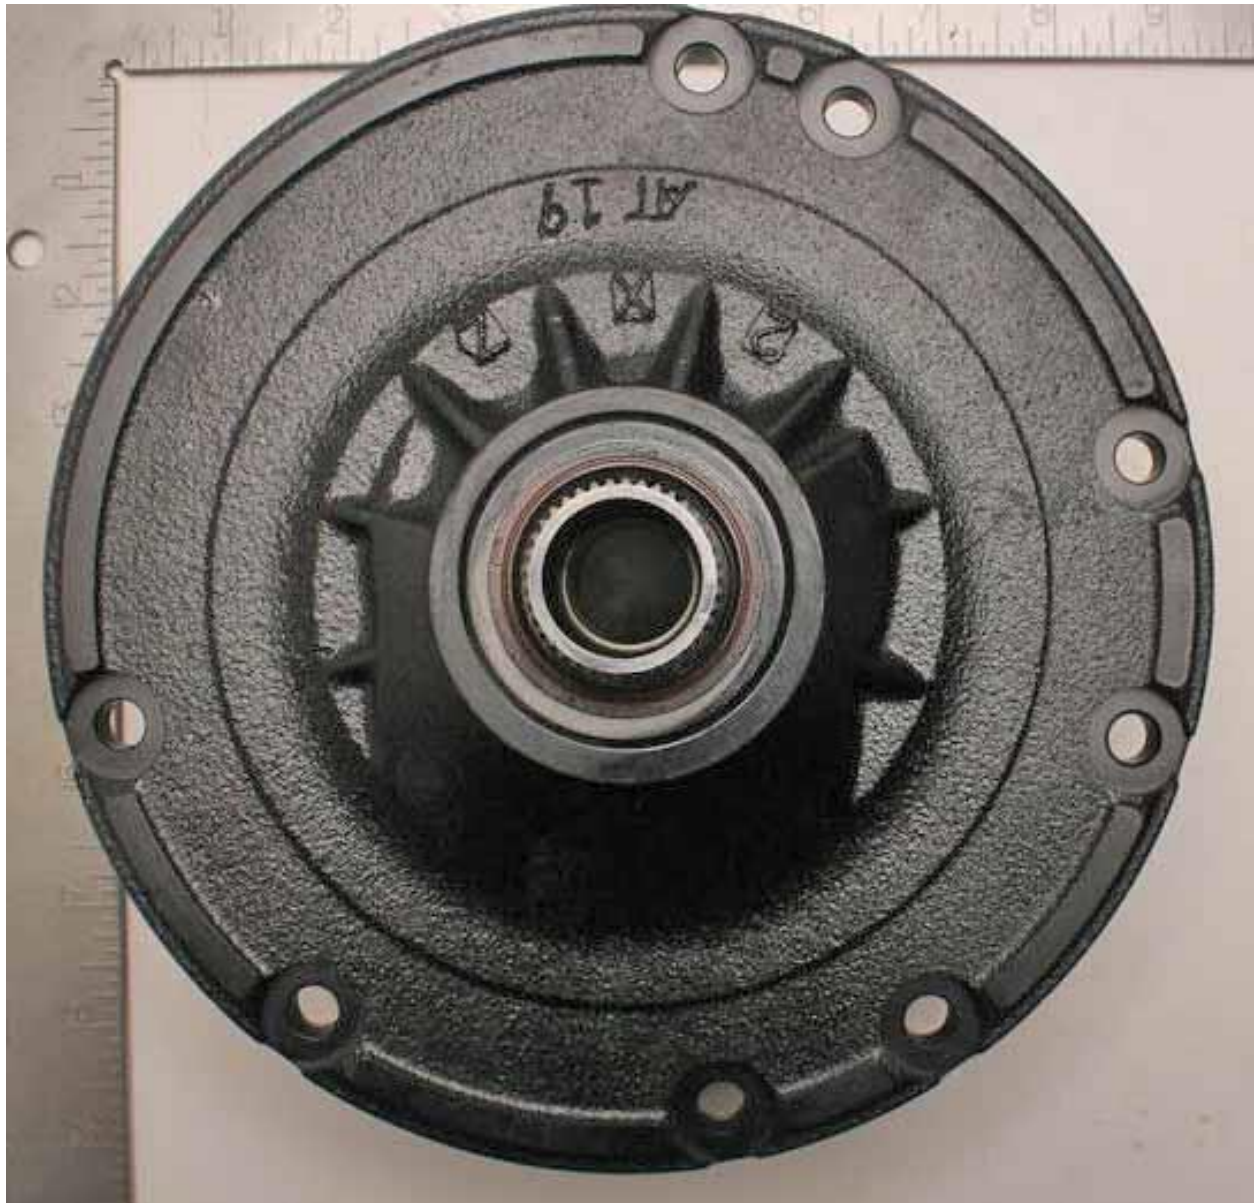
Torque converter/stator bushing in oil pump behind seal. This bushing is easy to remove and install with the stator removed from the oil pump.
