This write up covers removing and replacing the engine oil cooler lines on a '97 855 GLT wagon with light pressure turbo and automatic transmission. This car has 163K miles. The oil cooler lines were original.

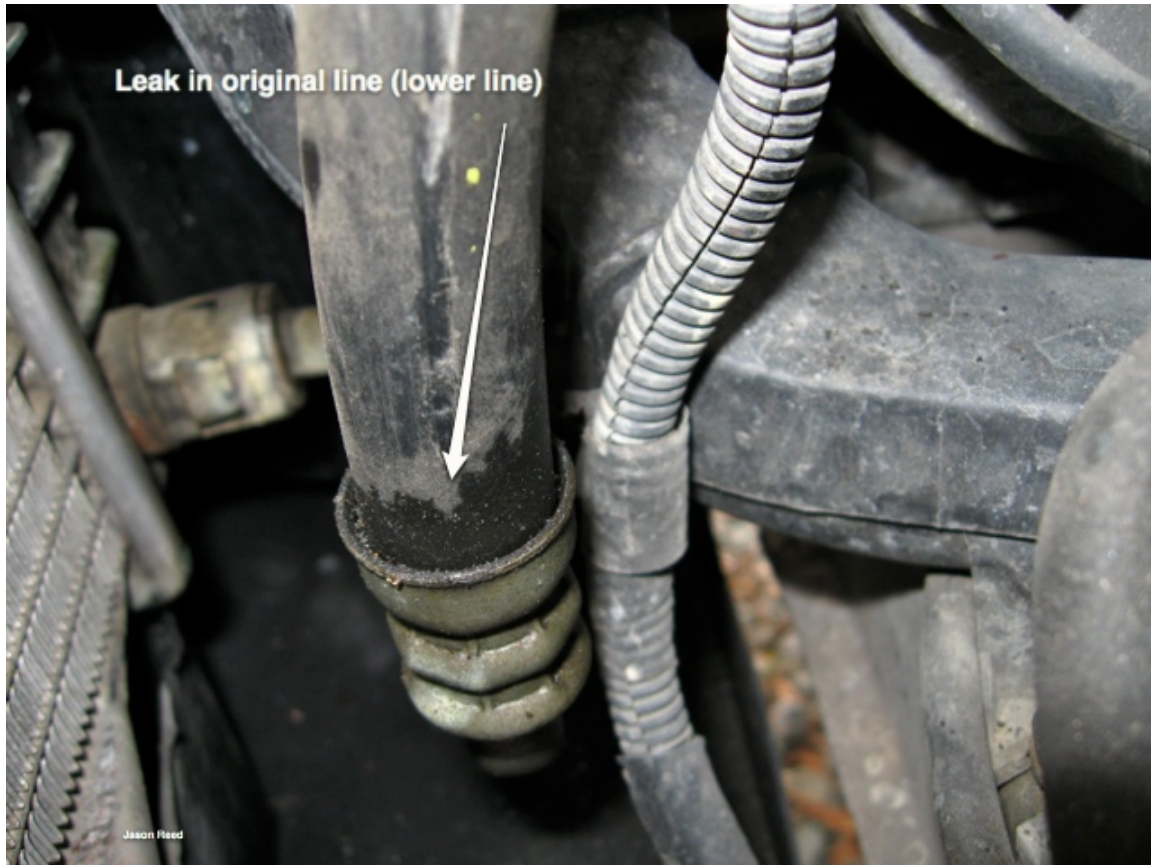
The lower cooler line (lower = the one that goes to the lower inlet on the radiator) had developed a very slow leak at the crimp nearest the radiator. It was leaking just enough to start to wet the hose above the crimp. Many other people have reported finding leaks here and replacing these lines so I wasn't surprised to find a leak starting on my hose. I decided to replace both upper and lower hoses at the same time to avoid having to repeat parts of the work later if the upper hose developed a leak too.

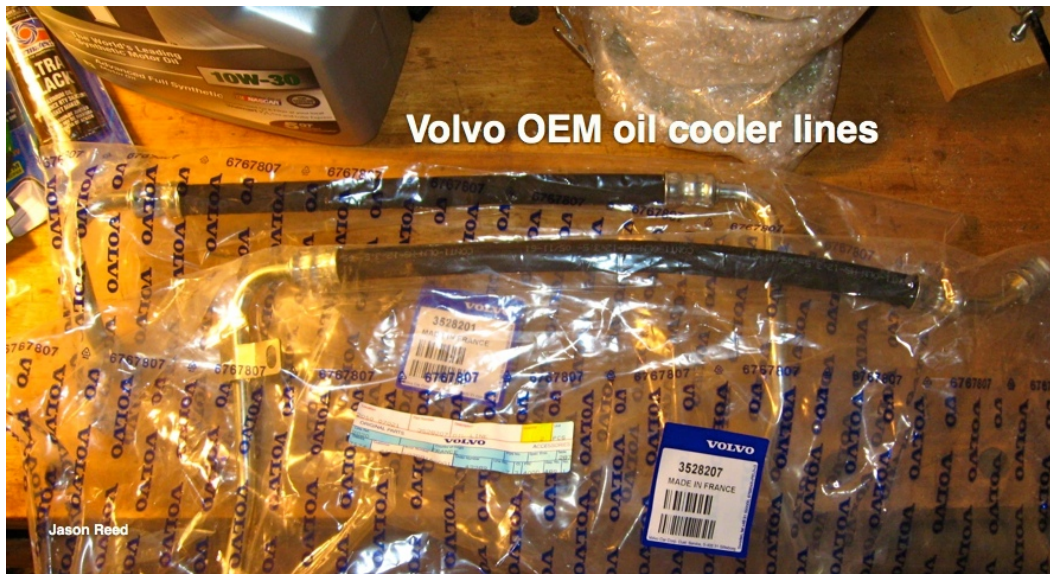
The photo below shows the new oil lines (Volvo part # 3528201 and 3528207). Others have had success using aftermarket lines, repairing the old lines or using rebuilt or refurbished lines and saving some money on parts. I decided to go for OEM replacement lines for several reasons: the original lines lasted about 17 years, which is an acceptable lifetime. I also wanted to save time during the job by not having to repair or modify the old lines. I've also found that from time to time my improvised solutions have failed later in unexpected (to me) ways, causing me to have to go back into an area or system and re-repair it – you may be more skilled or have a better track record than me in this regard. In the case of these oil lines, failure has the potential to allow the engine oil to leak out rapidly, potentially leading to engine damage due to insufficient lubrication. For these reasons I usually go for new OEM replacement parts even though the upfront cost is almost always higher than aftermarket or repair / refurbishment / rebuild options. It's a judgment call based on the car, situation, available time and funds, and other factors. I know some people won't agree with my decision to buy brand new OEM when there are less expensive options available.

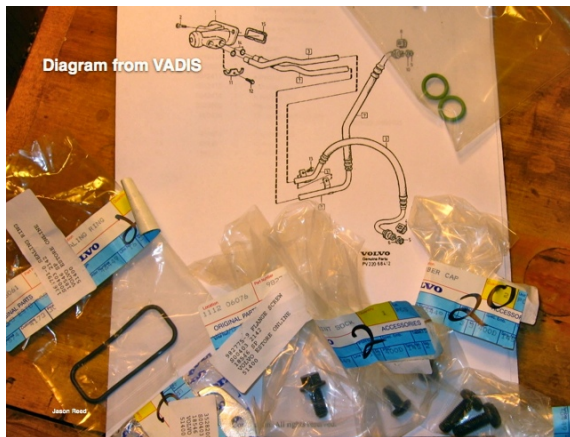
Left: VADIS print out of the parts in the oil cooler system, with some of the parts from Waltrip. Right: photo of packing list from Waltrip with all the part numbers. Note: the rubber caps on the last line of the packing list are for the brake calipers – I found a cracked brake caliper bleed screw cap that I wanted to replace – it's not part of this repair procedure.

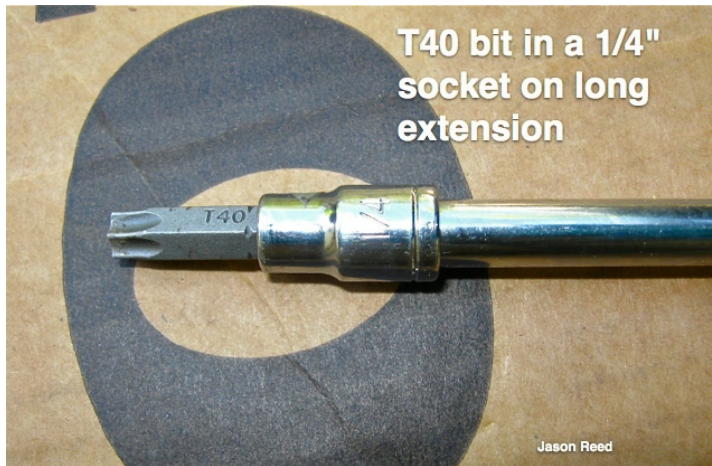
- 10mm open end wrench (useful for removing the 10mm bracket bolt)
- 10mm socket 1/4" drive (1/4" drive is more compact and gives better clearance)
- 1/4" 6pt socket for holding T30 and T40 bits
- T30 (thermostat flange bolt) and T40 bits (thermostat housing bolts)

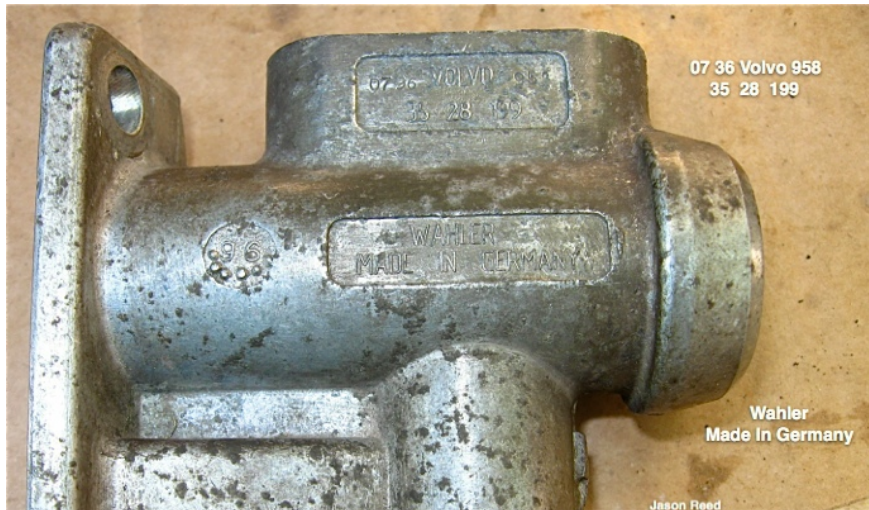
Note: I did not install a new thermostat. I tried to order a new one but found out from Waltrip and Tasca (the two dealers I contacted) that the part is discontinued by Volvo and is no longer available. When I got the old thermostat off I saw that it was marked "Wahler Made In Germany" and "07 36 VOLVO 958 35 28 199". To the left was stamped "96" with six raised dots which must be the year and month (June) it was produced (my car is a 1997 model year).

I wanted to install a new thermostat because the old one makes a "moaning" sound on startup in colder weather when the throttle is applied. It lasts for a few minutes and then the sound goes away as the engine oil heats up, presumably allowing the thermostat to open. The thermostat mechanism has a plunger and internal spring that I cleaned with brake cleaner fluid. Hopefully this will help quiet the mechanism down – it has been warm here since I did the job so I'm not sure if the cleaning has made any difference. Other than the noise, there didn't seem to be anything wrong with the thermostat.

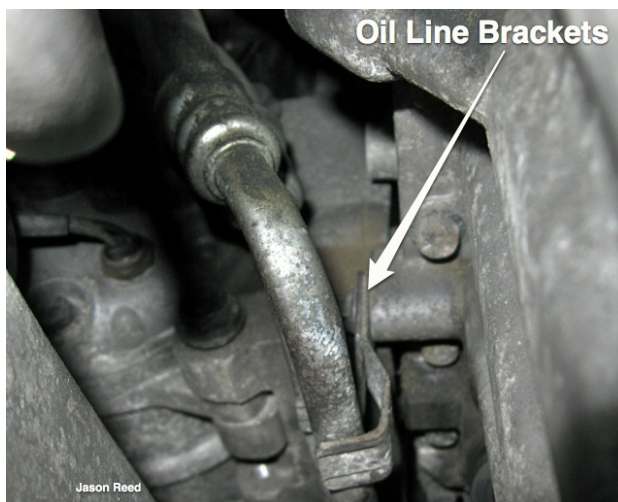
- 9) Under the car, loosen the 10mm bolt on the brackets holding the oil lines. I used a 10mm open end wrench for this job, one partial turn at a time. Once the bolt is loose I could turn it out relatively easily with my finger tips. This only took about 5 minutes – not as bad as I was expecting. I have read how others used a flexible joint and socket to remove the bolt. I tried that but couldn't get a good angle on the bolt due to interference from the AC compressor bolt. Depending on the car, you may have to try different approaches to loosening the bolt.

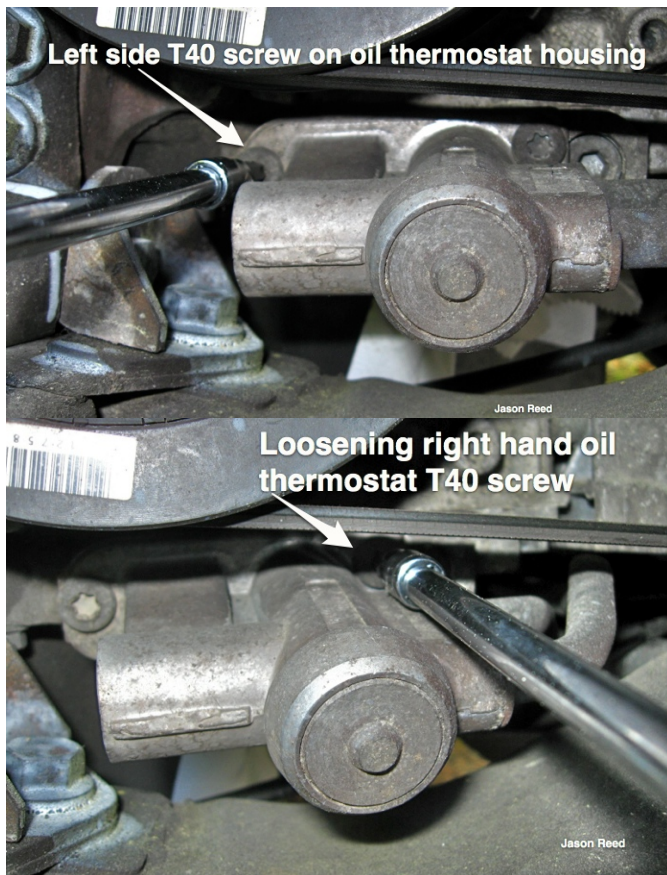
- 10) Loosen the thermostat housing screws with a T40 bit on a 1/4" drive with long extension, or else a long T40 bit.

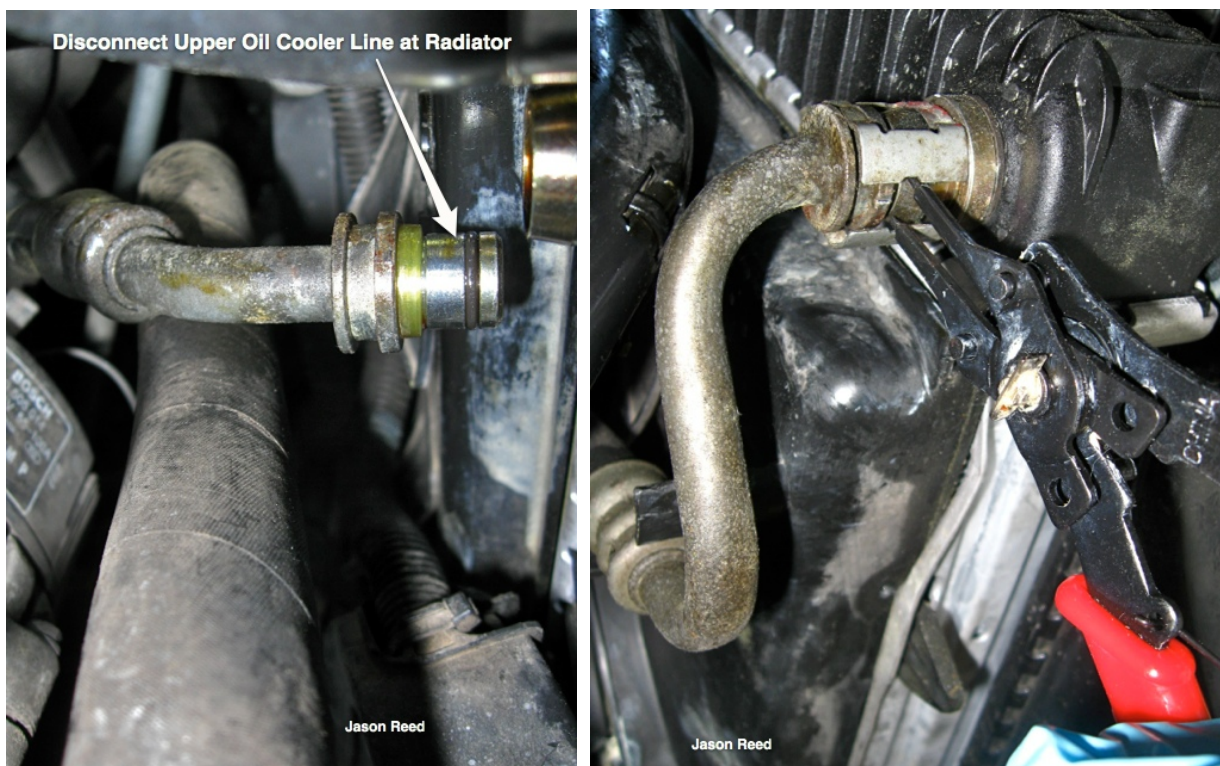
- 12) Disconnect the upper and lower oil cooler lines at the radiator. I used a pair of circlip pliers to prise open the clamp far enough to allow the line to be pulled off the radiator. This was a bit of a change in procedure for me – I used to pry the clamp open wide enough to pull it off of the line entirely before trying to pull the line out of the radiator. But I found it's easier to just pry it open enough to slide the clip and line out. On the lower cooler hose I could slide the clamp backwards away from the end of the line.

Left: Upper line disconnected. Right: Lower line clamp being spread with pliers.

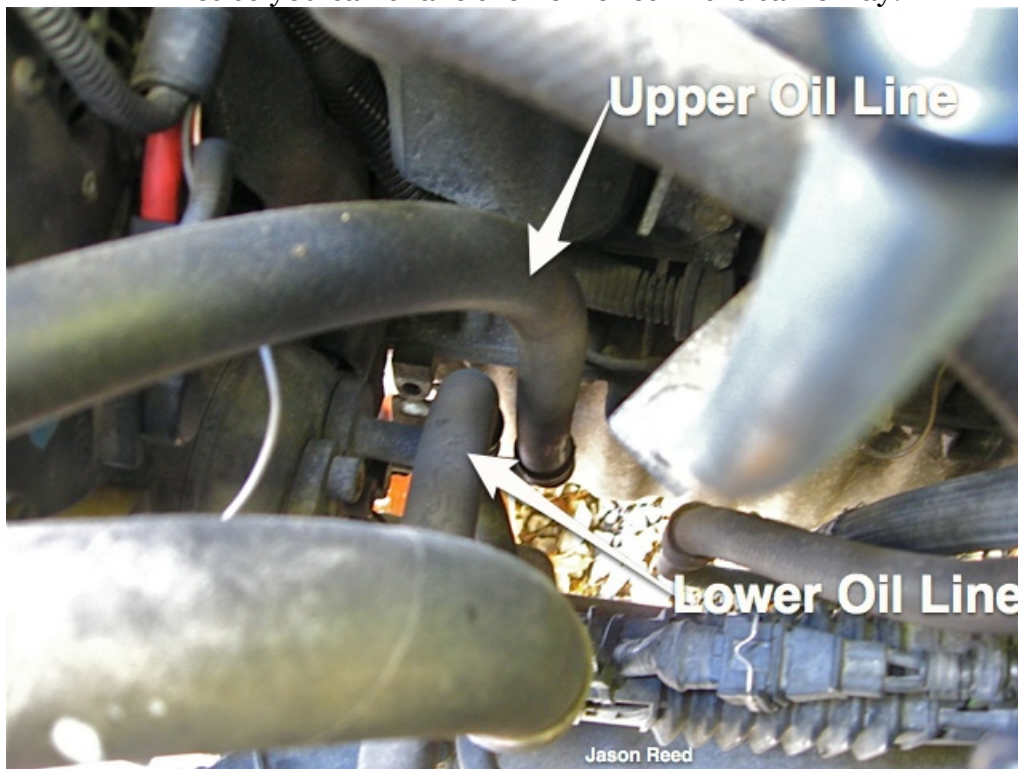
- 13) Make a note of the positions and pathway of the upper and lower oil cooler lines so you can snake the new ones in the same way.

General routing pathway for the upper and lower oil lines.

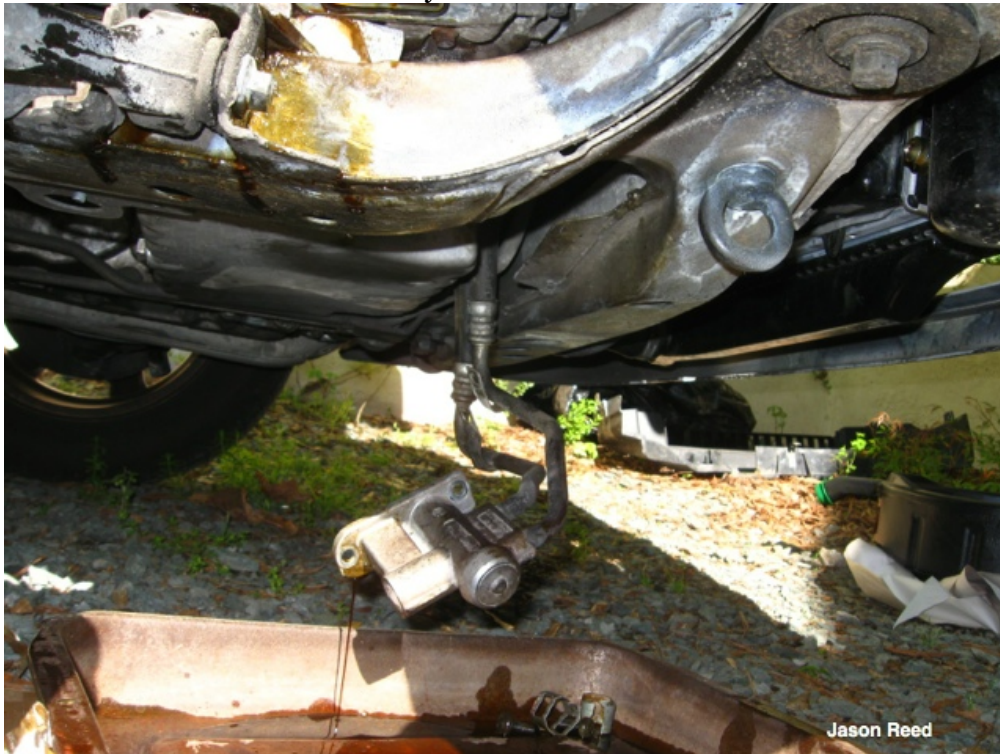
- 14) Push the thermostat back towards the oil filter area and pull it down from the engine. The lines will come along but will likely hang up on components above. I had to go back and forth a couple times from below and above to lower the lines, free them from obstructions, and then lower the thermostat and lines all the way out.

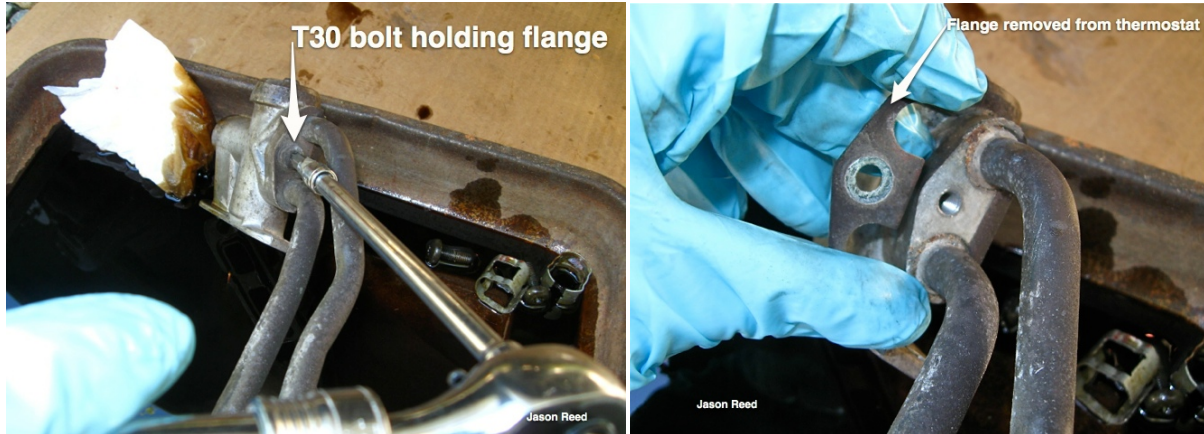
- 16) Disconnect the T30 screw holding the flange to the side of the thermostat. This flange holds the two oil lines in place.

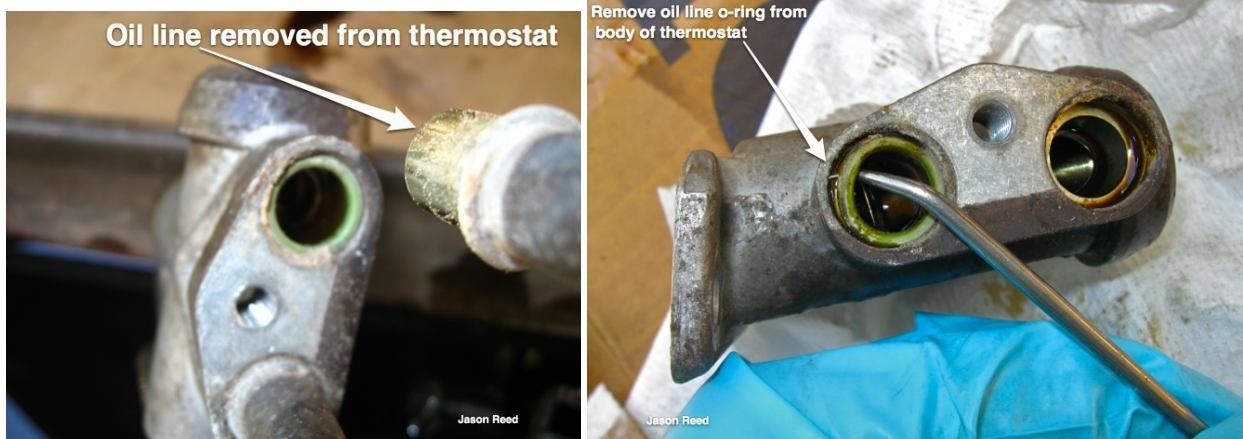
- 17) Pull out the lines and remove the old o-rings from the thermostat if stuck inside.

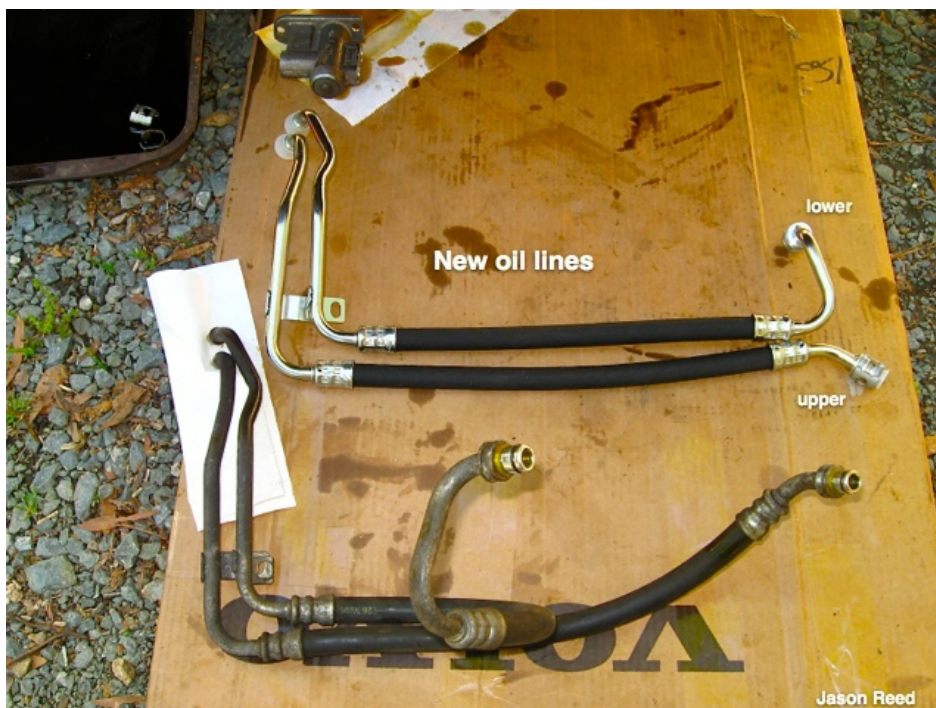
- 20) Position the new lines together with the brackets aligned. The lower line has a shorter bracket that lies on top of the upper line. The new lower line will be straight instead of curved. This is normal and the fitting will be in the right orientation when you bend the line over later for making the connection to the radiator.

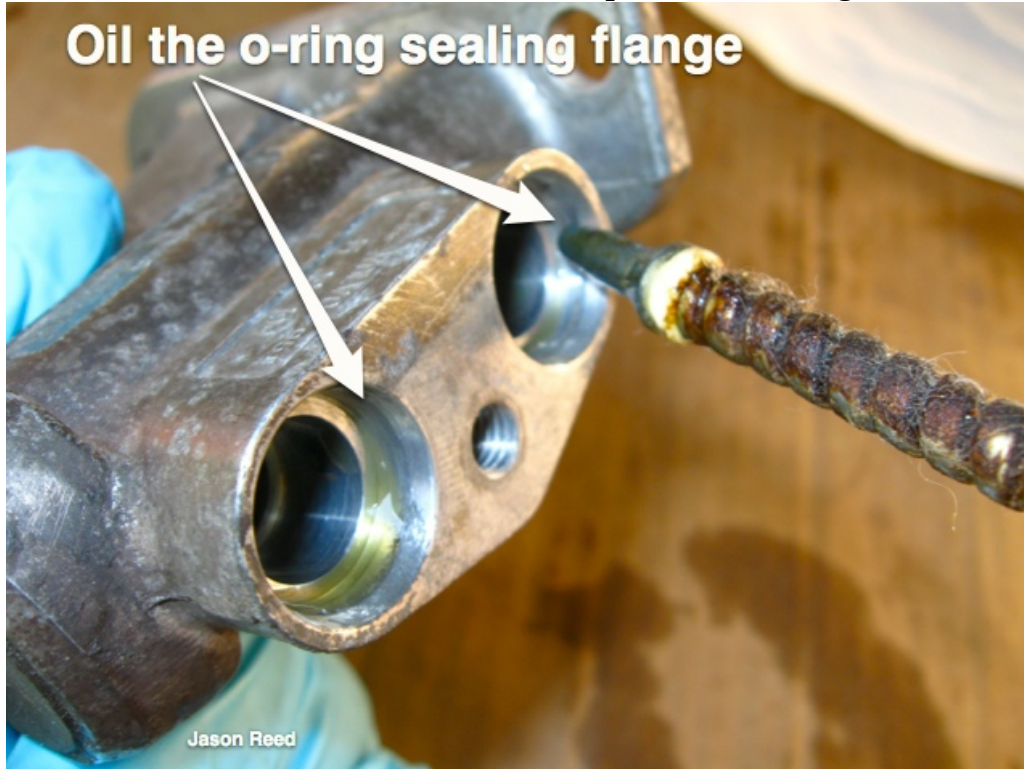
- 23) Oil the sockets in the thermostat (may be overkill – even after cleaning the thermostat I observed some corrosion and roughness on the line sockets, so I wanted to add extra oil there to protect the o-rings from cuts during insertion)

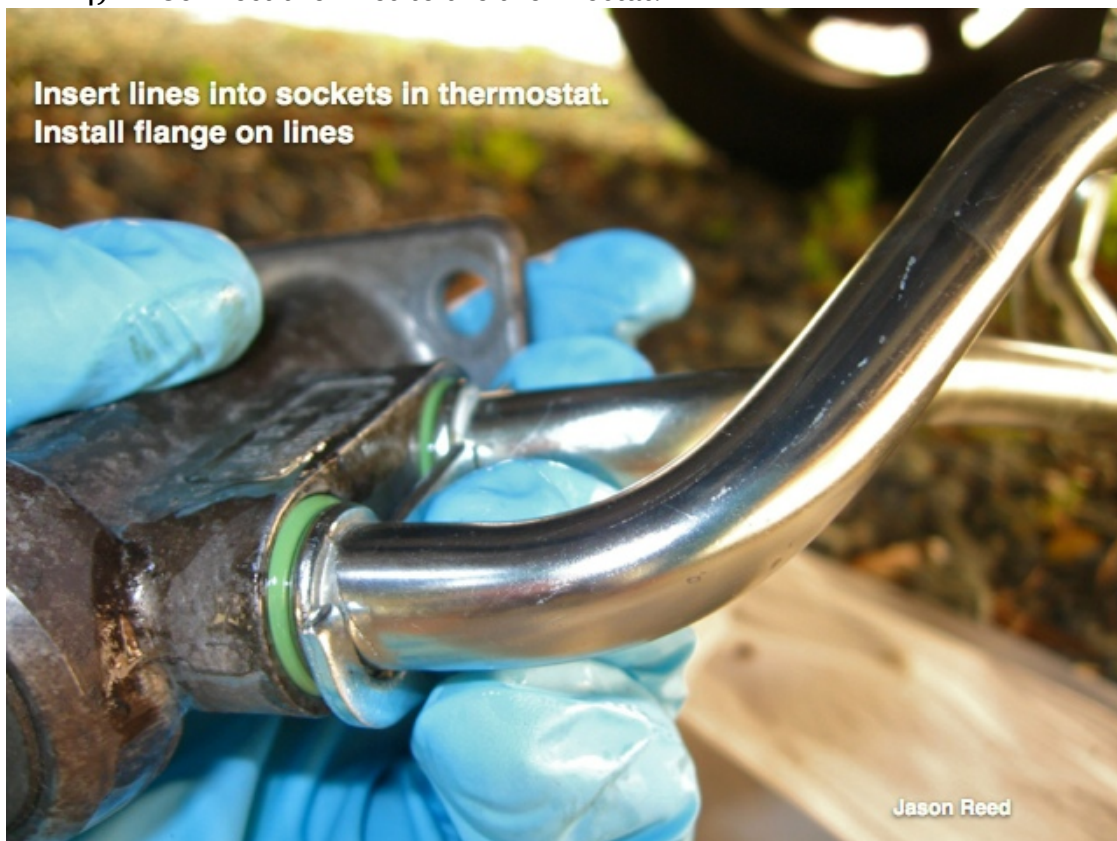
- 24) Connect the lines to the thermostat.

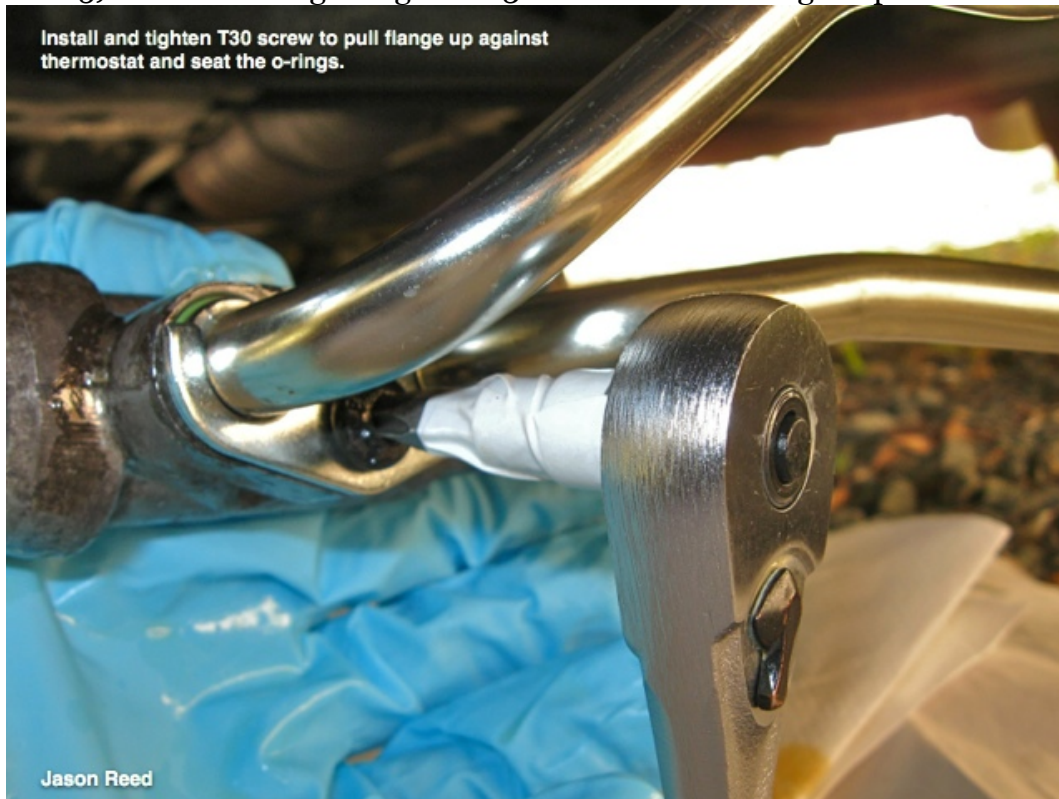
- 25) Install flange. Tighten T30 screw to hold flange in place.

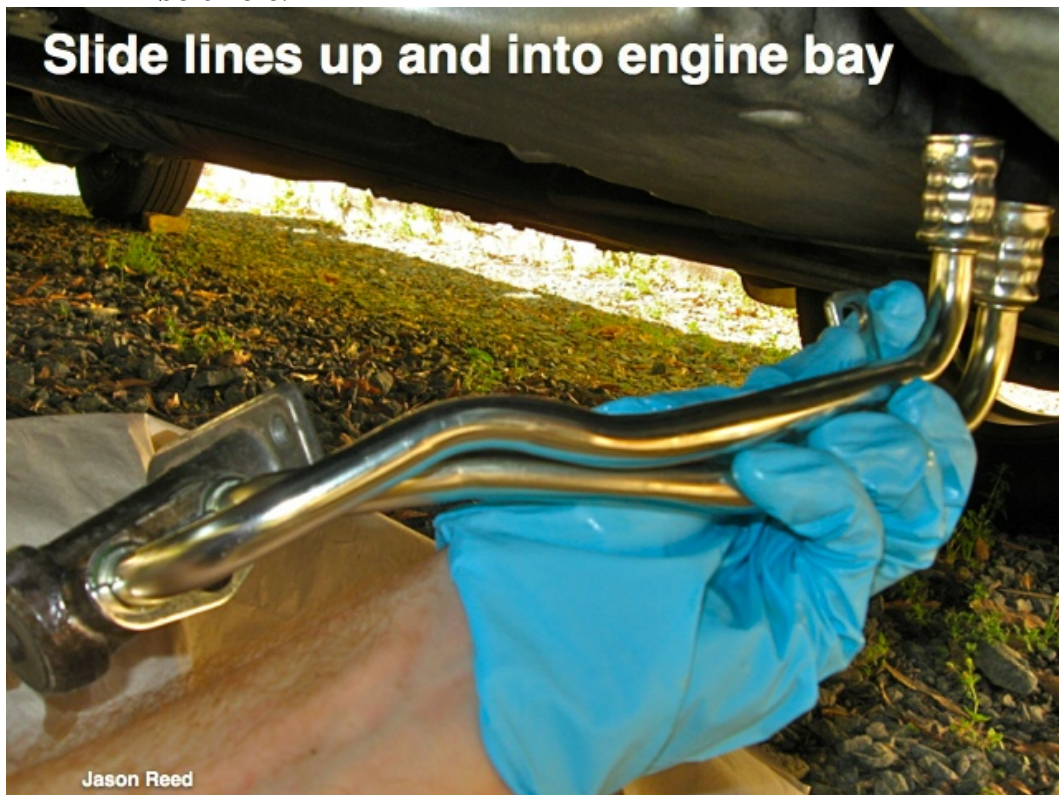
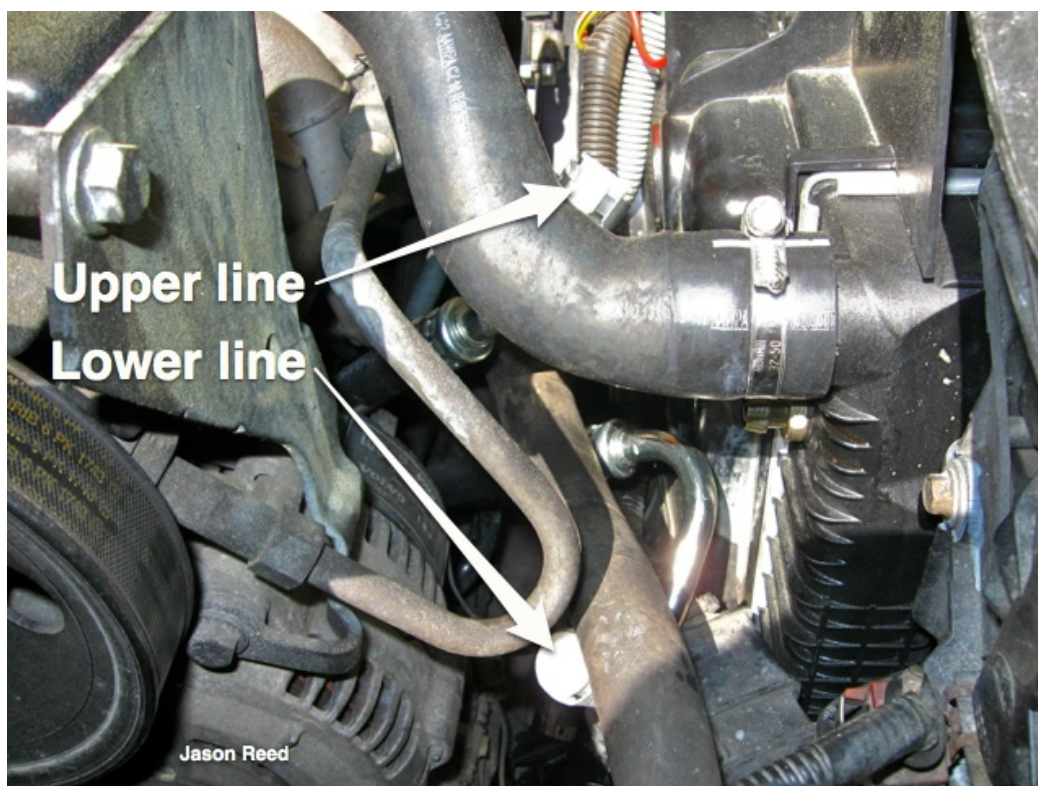
- 26) Snake the new lines farther up into the engine bay. Make sure the new lines follow the right pathway up into the engine. Align the brackets near the bracket bolt hole.

Up above in the engine bay you can position the upper and lower oil lines as shown.

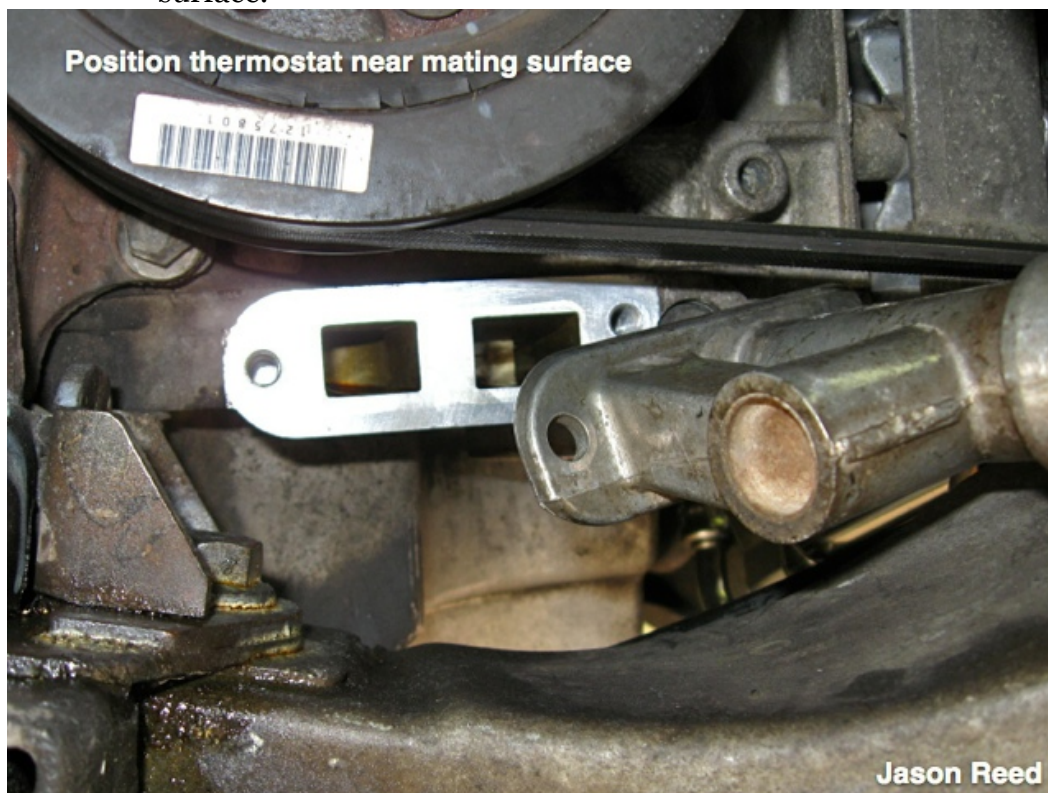
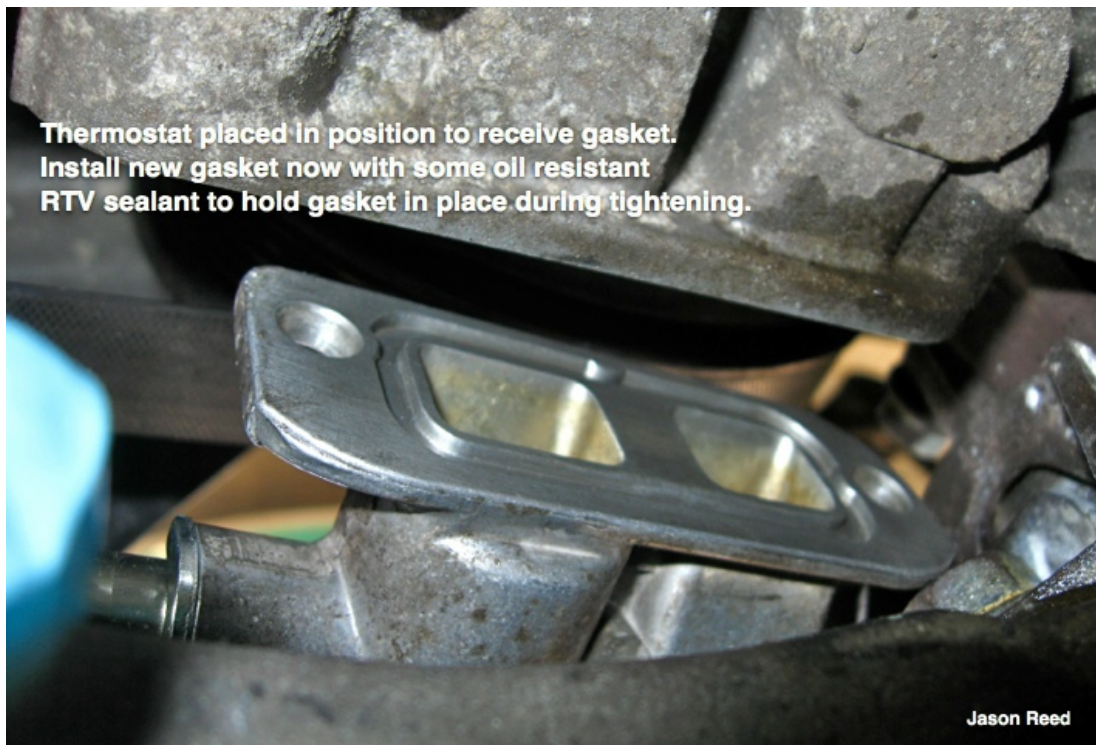
- 27) Lift the thermostat up past the oil filter area and position it near the mating surface.

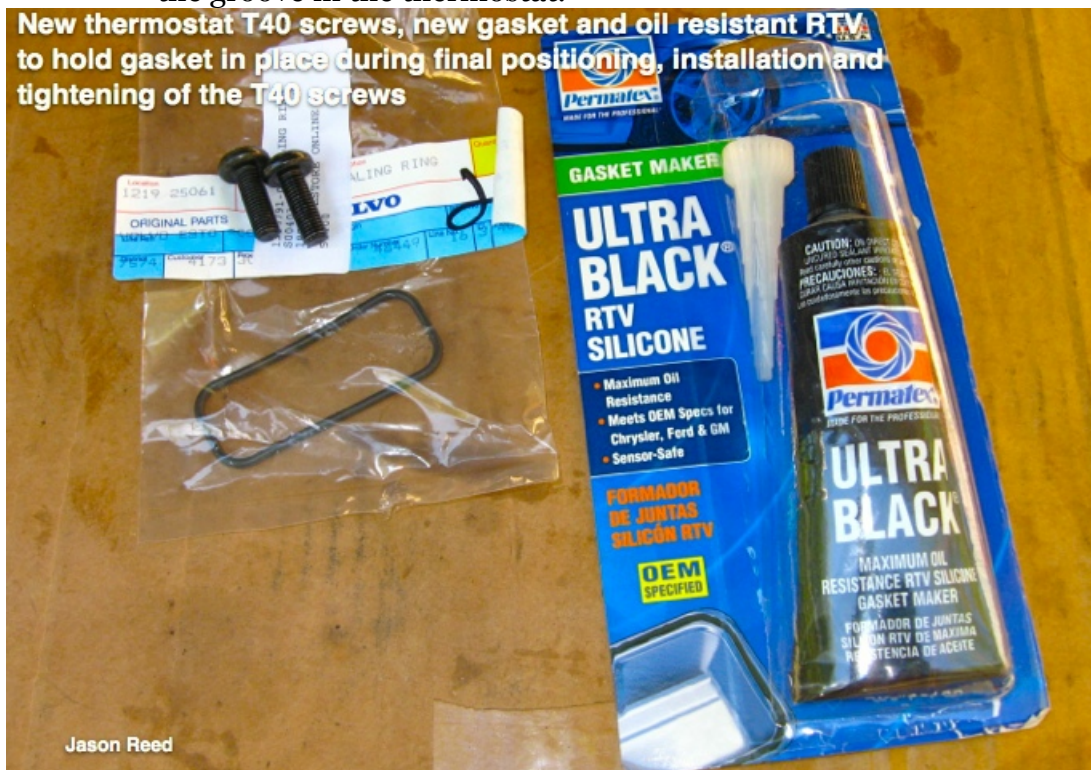
- 28) Apply RTV (I used black oil-resistant RTV) to the gasket to hold it in place in the groove in the thermostat.

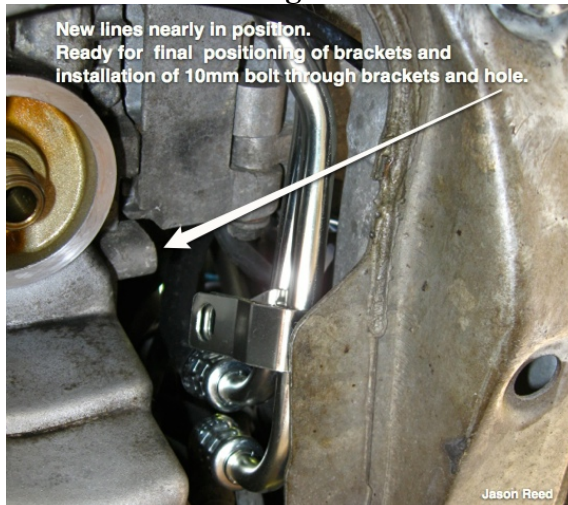
- 30) Position the oil line brackets over the bolt hole. Insert the 10mm bolt and tighten. Getting the bolt started was tricky. The access is so restricted that I had to use my finger tips to position and turn the bolt head. This took a few tries. Once the threads engaged it was much easier to tighten it up. For final torquing I used the open end 10mm wrench again. I tightened it up 'snug' – not too tight.
