# Technical Journal

Oil consumption, “Low oil Level” or “Oil level low” in DIM

REF NO:  
TJ 24643

ISSUE DATE:  
YEAR MONTH DAY  
2013 05 15

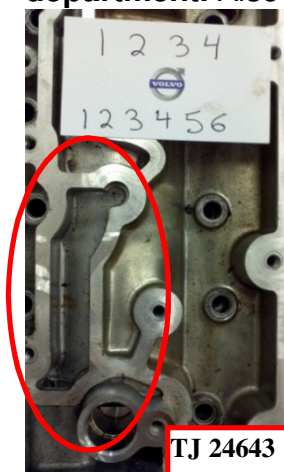
**Photo 2. Intake side of PCV diaphragm**

Remove the PCV box and photograph the channel on the intake side of the diaphragm, shown in Photo 2 below. **This photo will be requested by the Prior Approval department.** Also include your dealer and the vehicle's chassis number in the photo.

Frame the photo so the cavity closest to the vacuum source (next to the exhaust cam position sensor) is completely visible. It is best to position your camera directly above this area looking straight down instead of taking the shot from an angle so the bottom of the cavity is clearly seen in the photo.

If the spark plug from cylinder #6 has more soot/ash than the others and the oil galley looks like that shown in Photo 2 (clean), then the cam cover is most likely at fault.

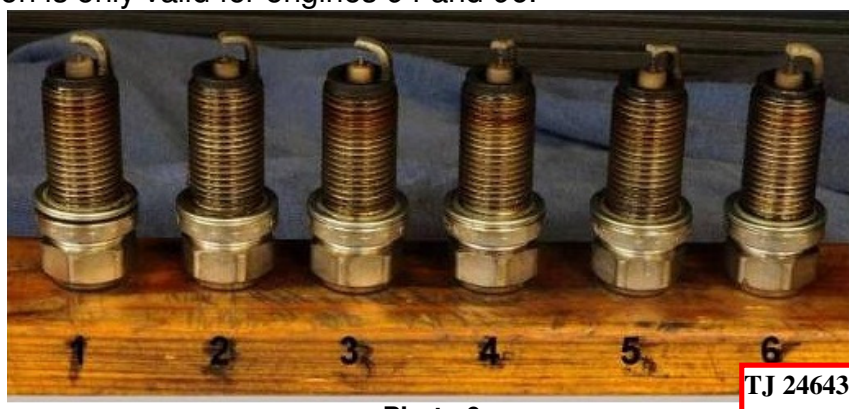
**Photo 9**

If the spark plugs are all equally dark (see Photo 9 below), then the oil control rings are at fault. See "Information on piston rings" below.

A new piston and oil control ring were introduced into production at engine date 301011B21530 (DDMMYYxxxxx). Follow the steps below for the service solution for engines built up to this date.
