## Retailer Technical Journal 14545

### Water intrusion into passenger compartment S40 / V50

Date 10-7-2008

Volvo Cars of North America, LLC  
Technical Support

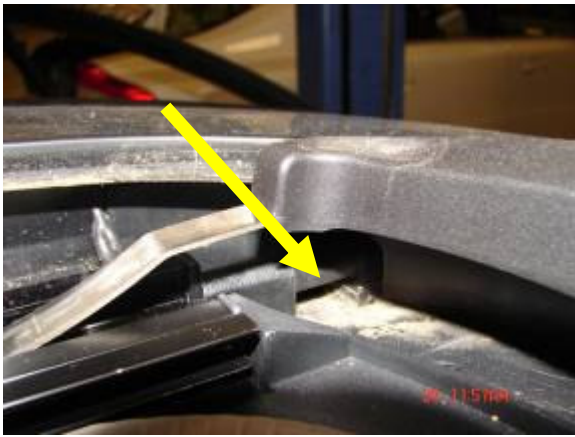
Although difficult to see, feel with your hand and ensure the hose is installed in the sound trap.

At the front - corner area of the sunroof opening of the side with the water intrusion: have helper pour water into the sunroof drain area and observe the water traveling thought the hose.

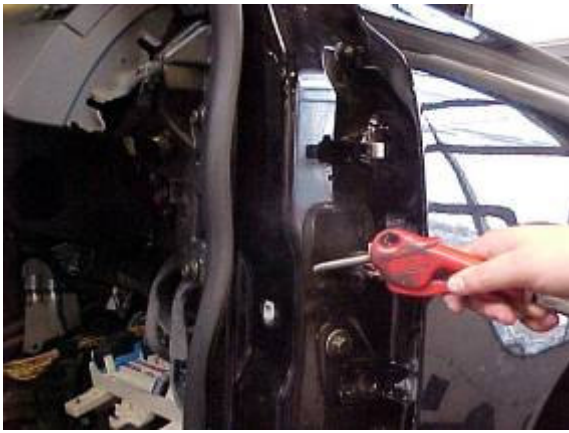
- lower the window 12 inches (30 cm).
- ignition off.
- disconnect the door assembly harness.
- remove the door from the vehicle as shown.

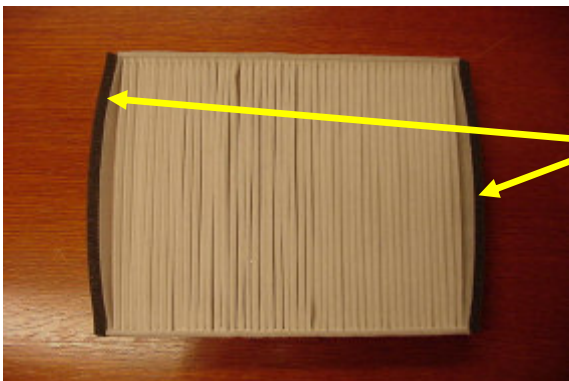
The following improvements of the cabin filter have been introduced:

- Closed cell structure foam on the sides of the filter element.
- More flexible filter core and rounded sides to follow the shape of the HVAC housing.
- Optimized dimensions of the filter element.

Remove the side cover as per VIDA:

- Removal, replacement and installation
- 8 Body and interior
- 87 Climate units
- Air distribution, L.H.D
- Pollen filter climate control system

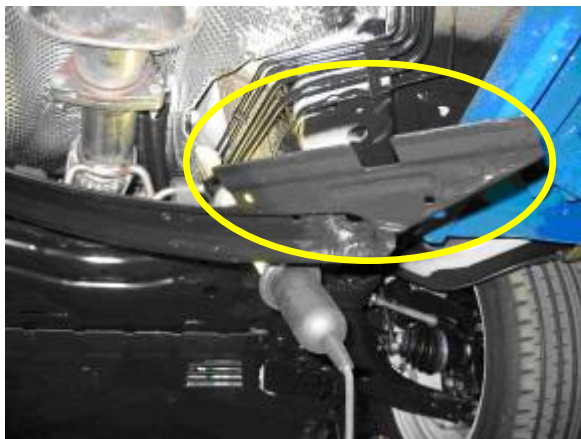
Vehicles with two wheel drive, loosen the cross member as shown here.

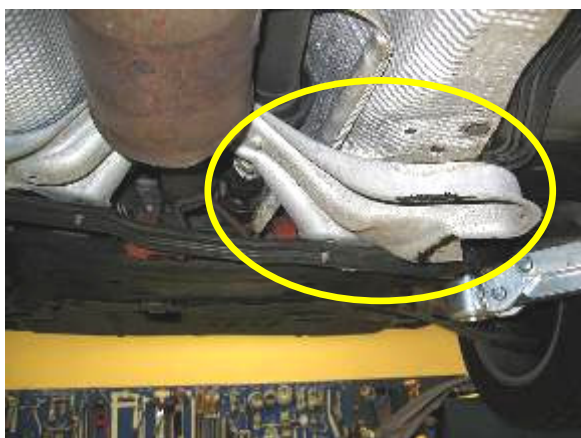
Vehicles with all wheel drive, loosen the cross members as shown here.
