S80 (07-), 2008, B6304T2, TF-80SC AWD, L.H.D

37206-2

### Control module relay box passenger compartment

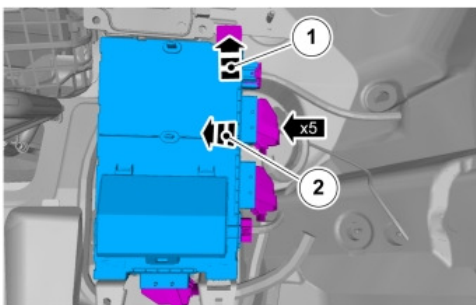
**Note!** Make sure that the component terminals are not bent or damaged.

Remove glove  
compartment

Refer to: Glove  
compartment
