## Aisin-Warner AW55-50SN valve body replacement in 2002 V70-XC

**Overview:** *This is an update to the previously published procedure.* I have performed this procedure twice, first on my 2002 V-70 XC and later on my 2002 V-70 T5. I removed and re-installed the valve body on the Aisin-Warner AW55-50SN transmission. The valve body was rebuilt both times by Valve Body Builders (<http://www.valvebodybuilders.com/index.html>)

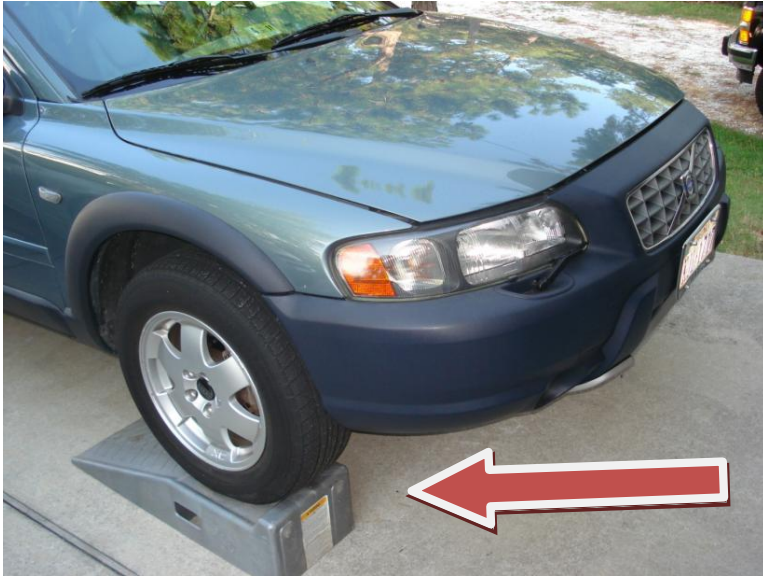
Remove the splash guard under the engine. Remove the splash guard under the radiator. It consists of 3 pieces. There are two screws that attach the center of the guard to the two edge pieces. T-25.

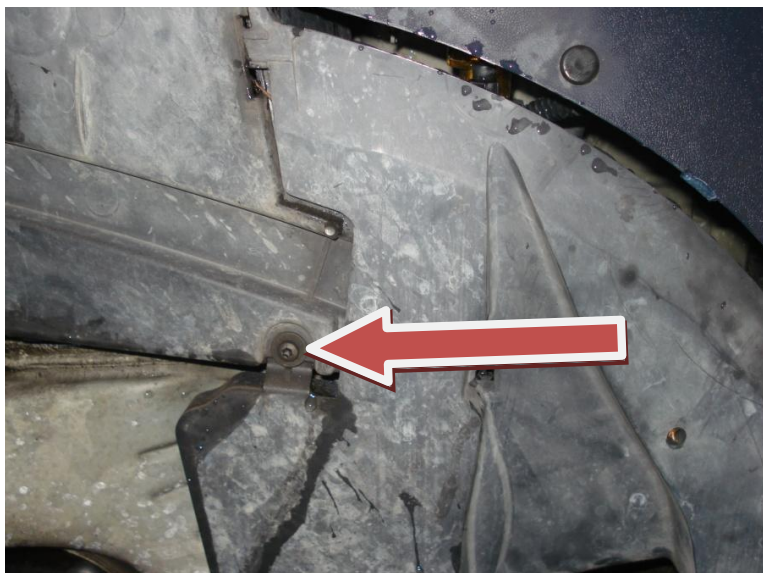
There are two clips that attach the edge pieces to the inner fender liner.

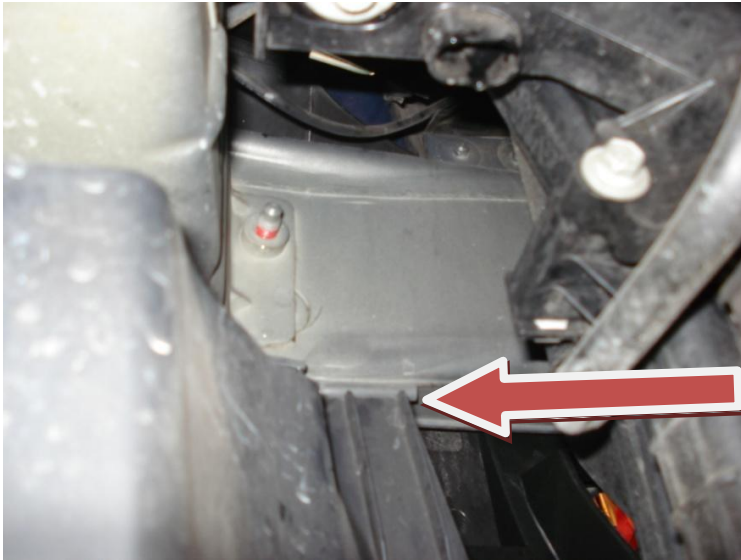
The center splash guard is held in place by a 10MM bolt on either side and two catches on the front of the cover. Press the catches up with a long screwdriver and pull it rearward to remove.

Catch location looking up and forward.

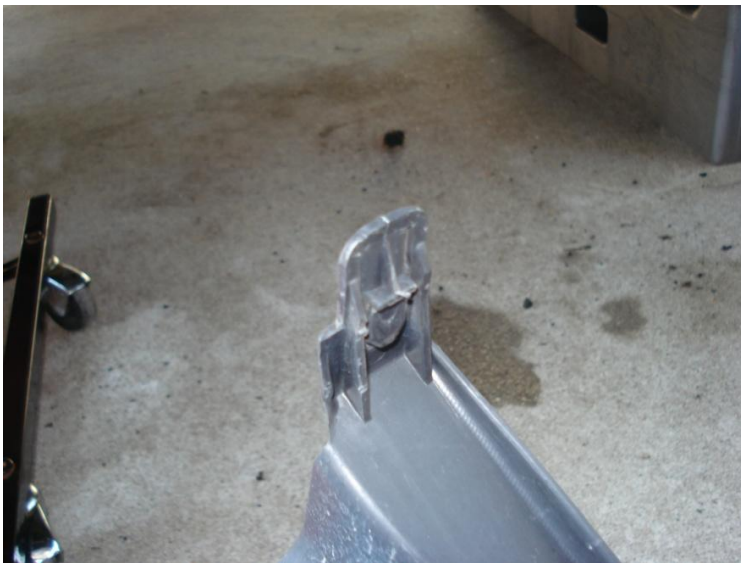
Catch detail

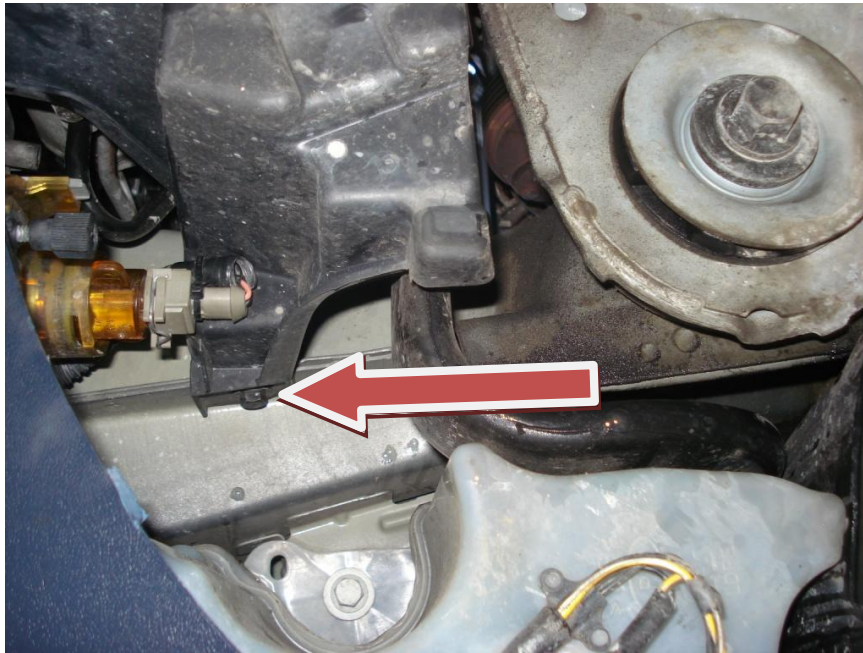
10MM bolt location. Passenger side shown.

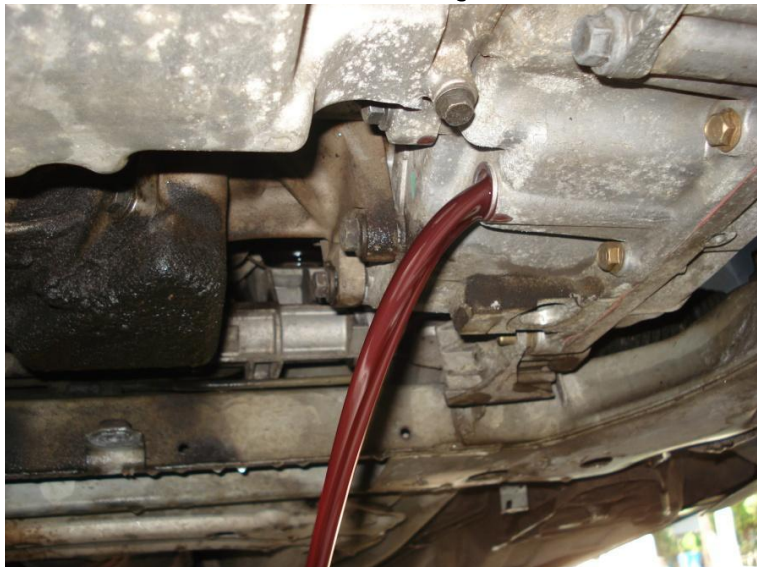
Drain the transmission fluid. 24 MM wrench required for the drain plug. Measure the amount of fluid (in my case, about 3 ¼ Qts.) Install a new sealing ring when re-installing the plug (same ring as the oil plug). Drain plug torque 40NM. It's important not to overfill the transmission when refilling later.

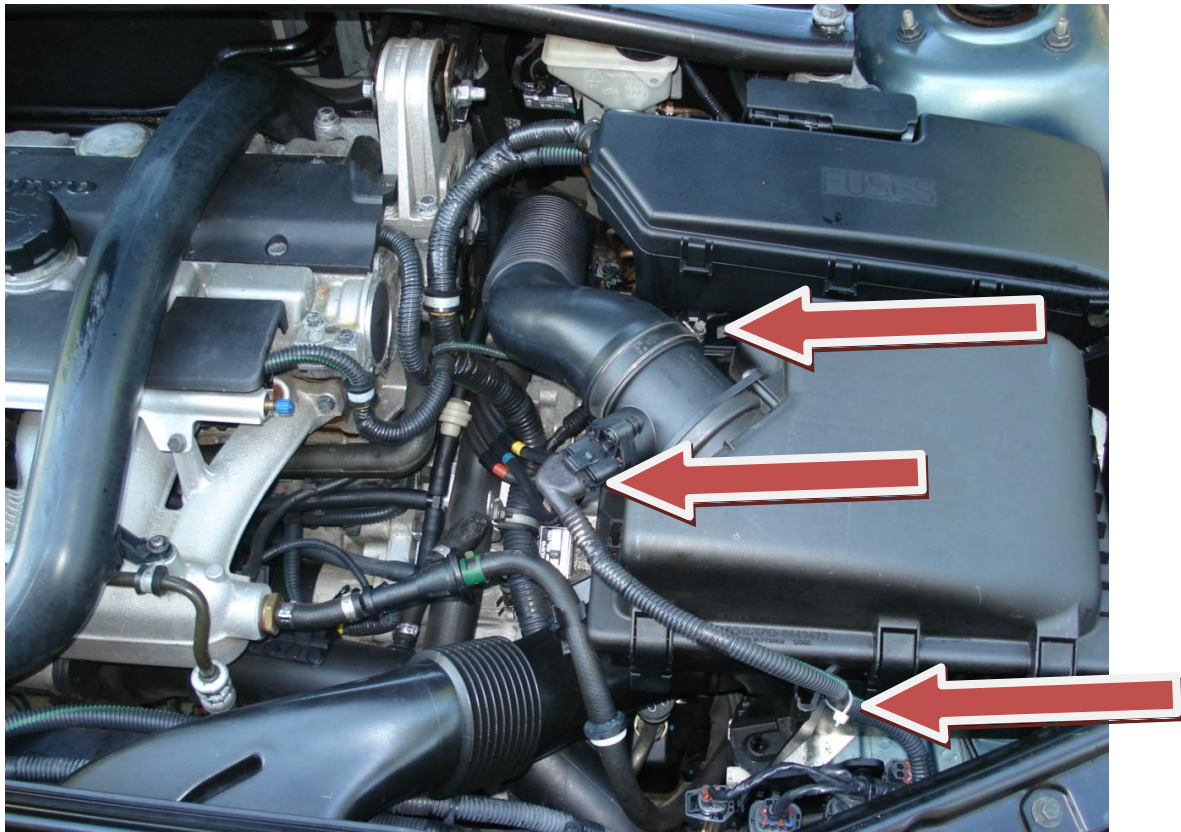
Remove the airbox lid. Then remove the ducting to the front of the radiator support from the airbox.

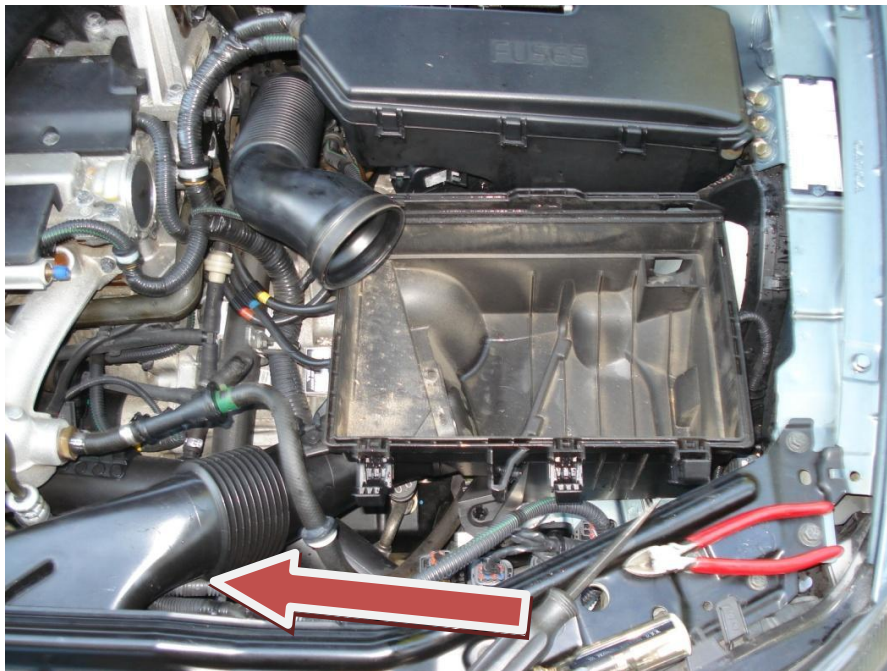
The next step is to remove the airbox base by releasing 3 clips. The manual says “pull up sharply”. My method is to use a 10 MM socket (shown) to compress the fingers of the clips while pulling up. 3 clip locations shown with the airbox removed.

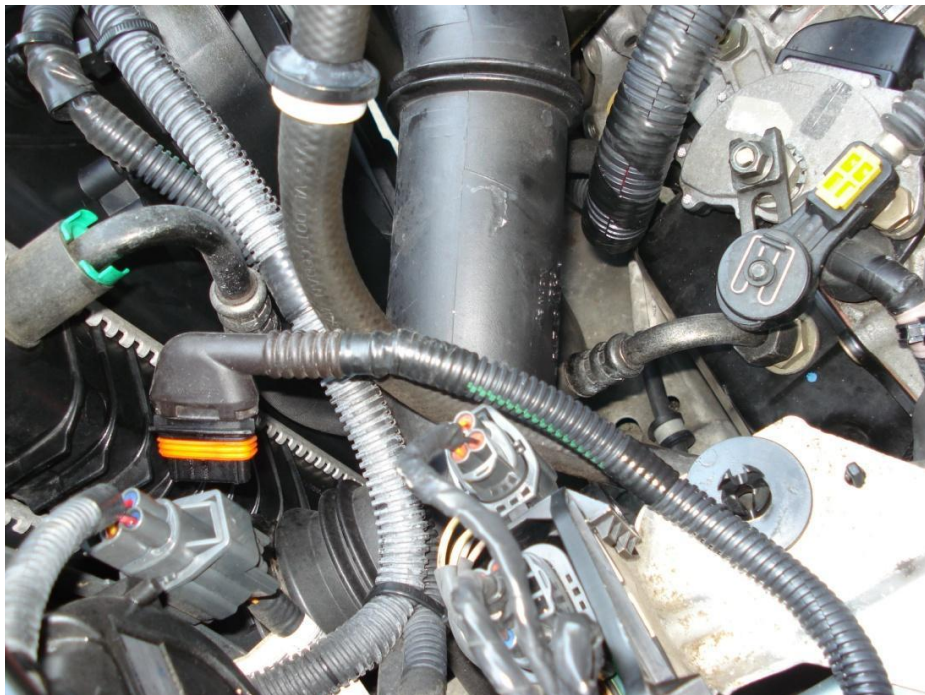
With the airbox removed, you have much easier access to the top of the valve body cover and transmission lines.

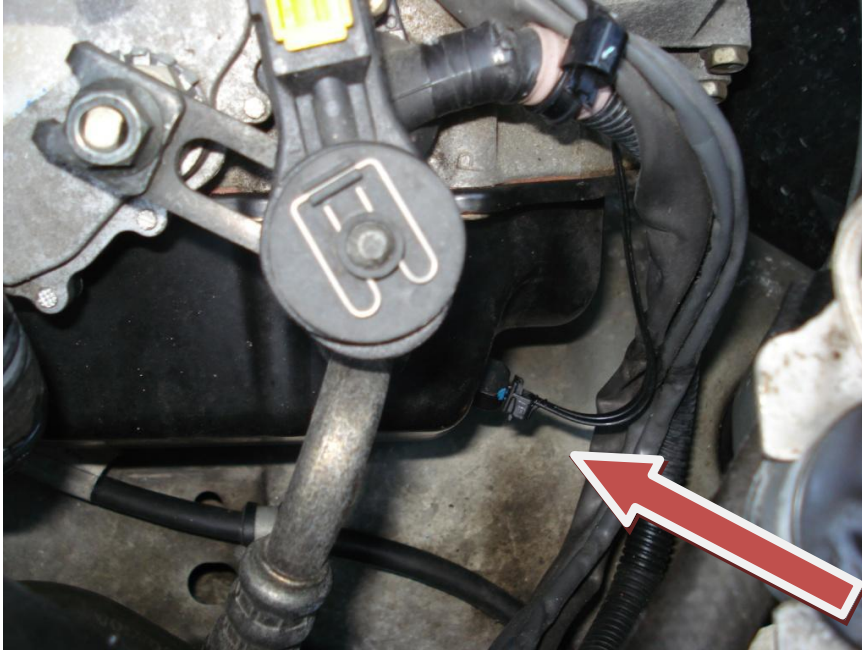
Disconnect the oil cooler return line from the cover. 22MM wrench. If you removed the airbox, you may be able to use an open-end wrench, as I did on the XC. On my T5, the line was frozen ...requiring the use of a crow's foot flare nut wrench for the line and a 7/8" tappet wrench (thin profile) to hold the transmission cover fitting in place. The cover fitting would turn if torque was applied only to the line, precluding loosening the line and potentially damaging the seal in the cover, *which is not replaceable*. Note that 22MM is precisely 7/8".

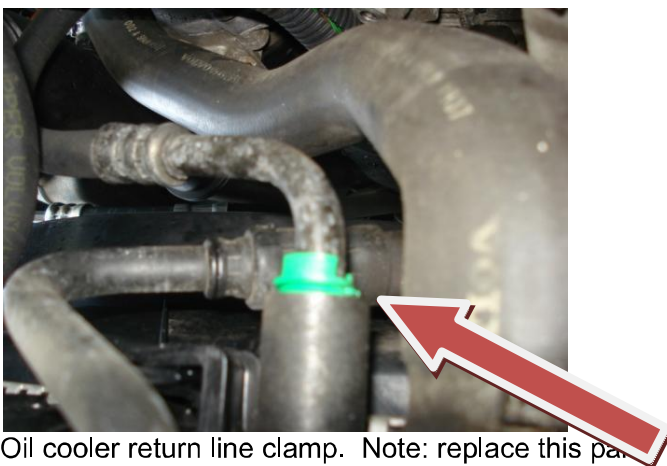
Oil cooler return line clamp. Note: replace this part.

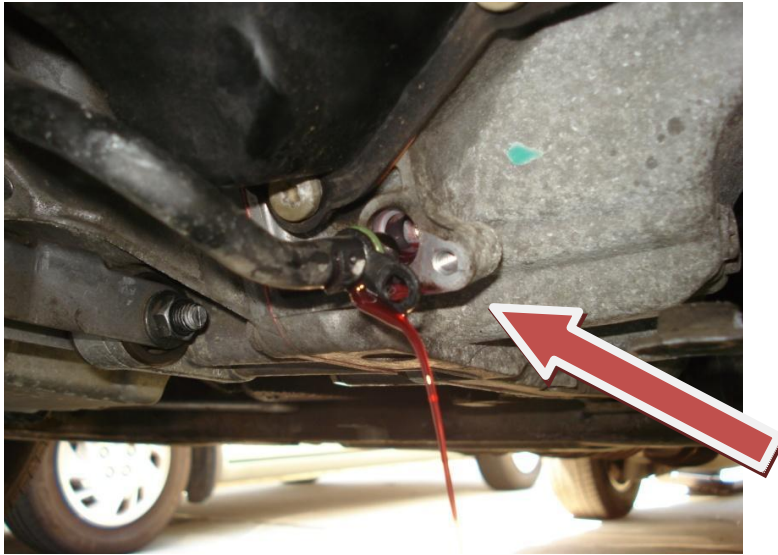
Remove the 12MM bolt that retains the bracket on this line and the dipstick tube to the transmission case.

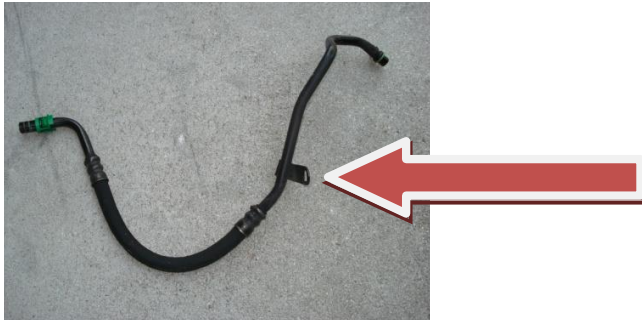
12 MM bolt is not visible here but located just under the dipstick. Not easy to get to. Bracket shown on hose.

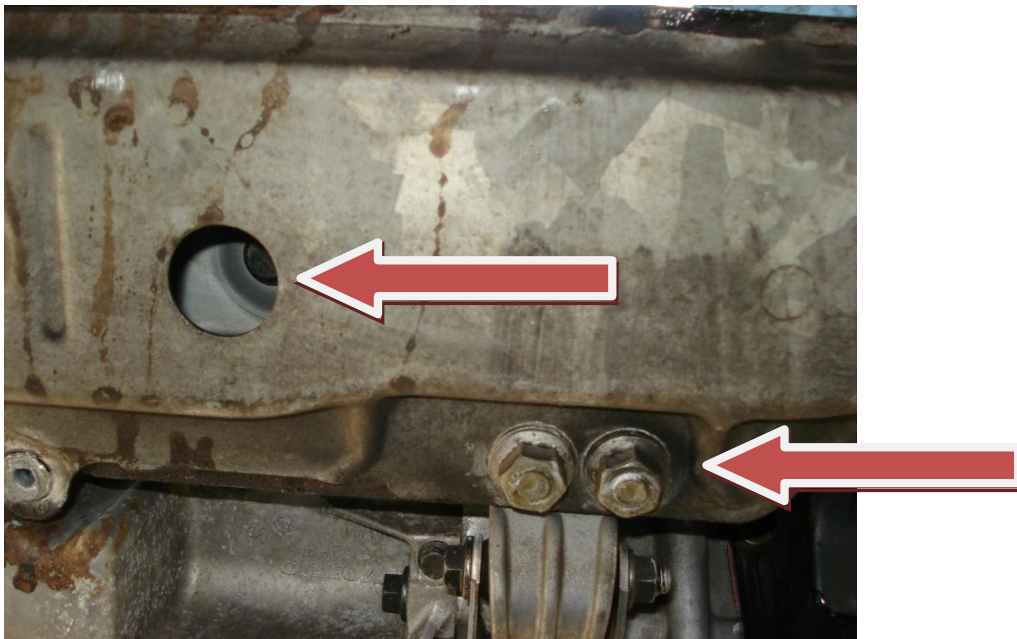
Remove the 10MM bolt that holds the ground wire to the sub-frame.

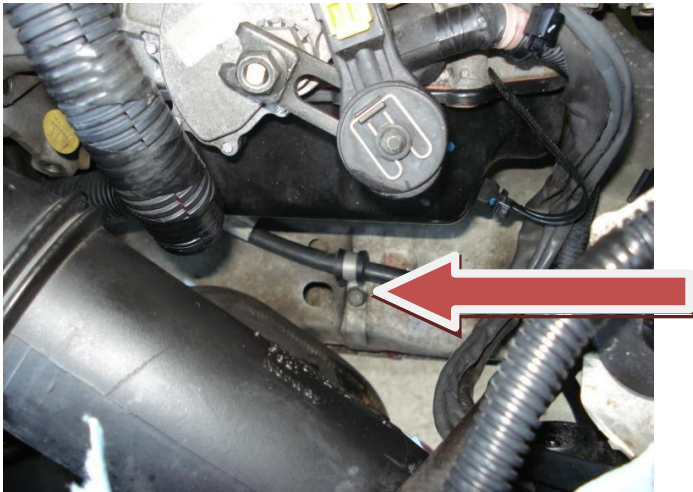
Remove the 10MM bolt that holds the wiring harness to the subframe on the passenger side.

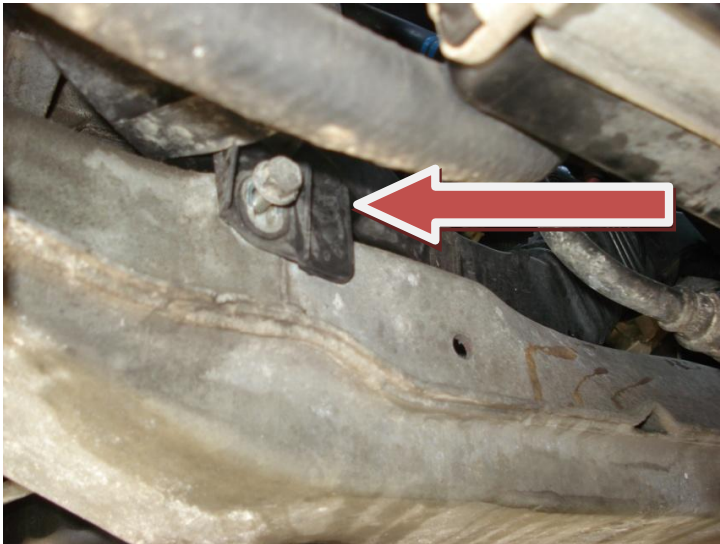
Install the Transverse engine lift. Volvo sells one...for about \$600. I borrowed one.

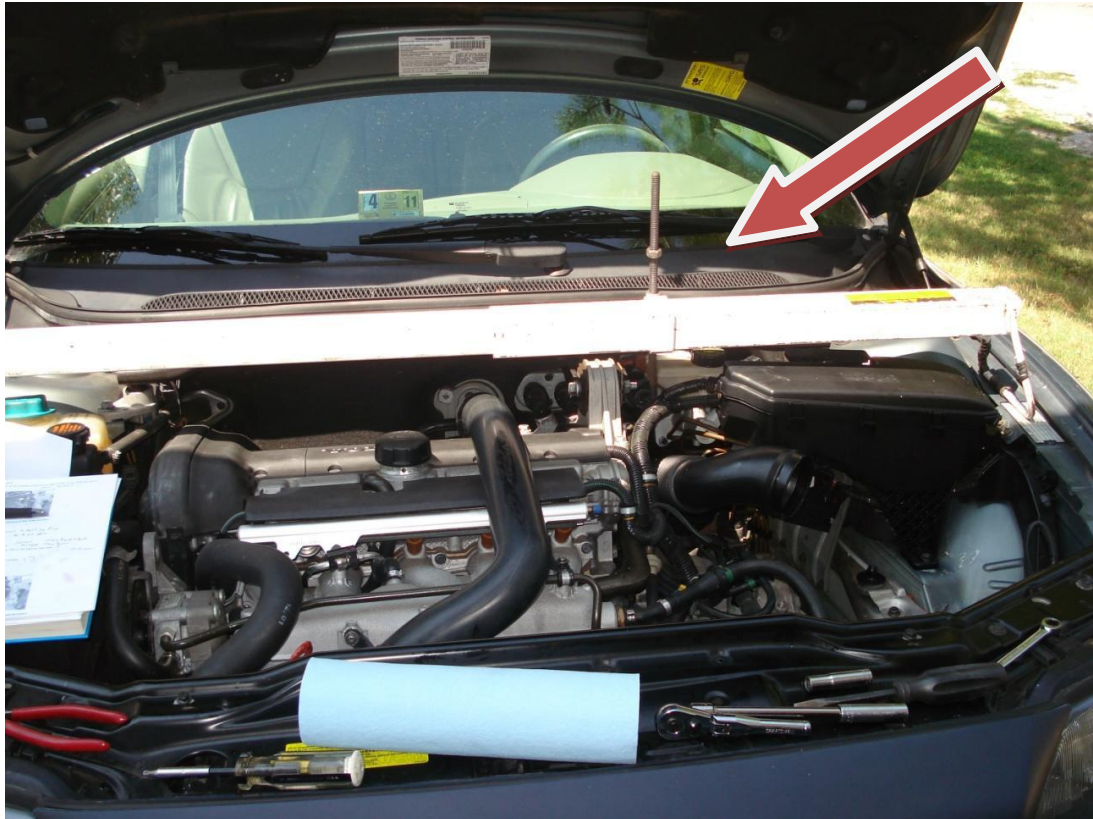
The lift is the white bar across the engine bay. The threaded rod hooks into the lift bracket on the engine.

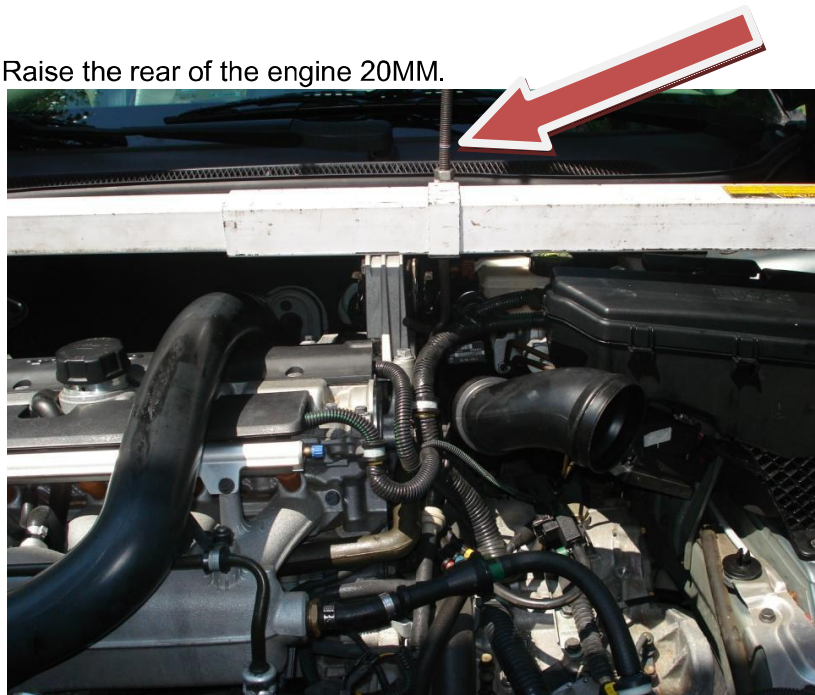
Raise the rear of the engine 20MM.

I used a mark on the threads to measure engine lift.

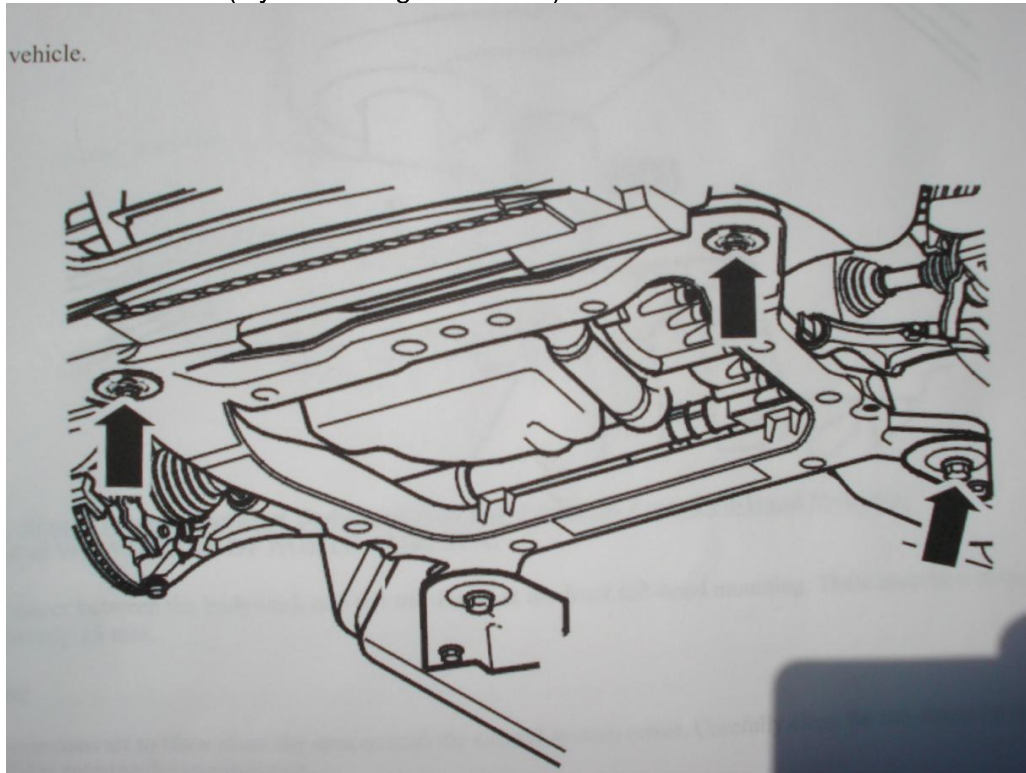
Loosen the front subframe mounting bolts (18MM). Remove the left front bolt. Loosen the right front bolt until approximately 5 threads remain engaged. Loosen the left rear bolt two turns. Note: these bolts are tightened to 105 NM, then tightened further 120 degrees. They have thread locking compound on them. An impact wrench and sockets are recommended to loosen them.

**Important:** Volvo recommends that these bolts be replaced.

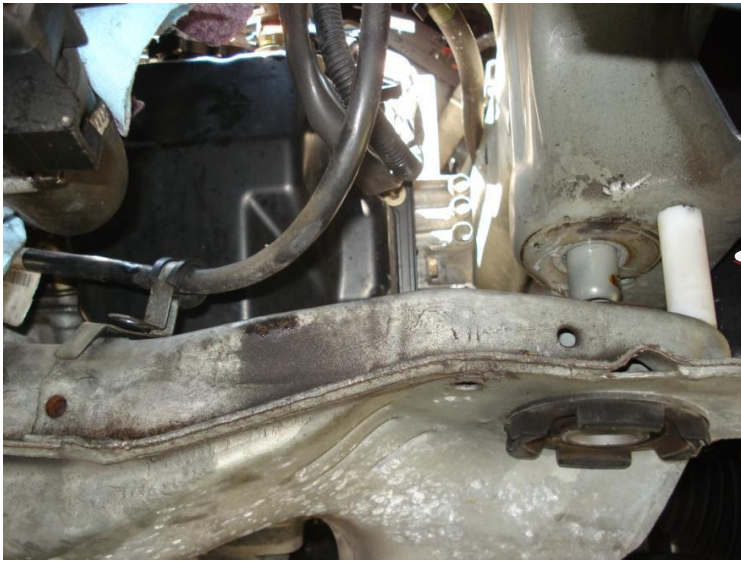
Using a pry bar, insert a spacer of 55MM between the left front of the subframe and the frame. I used a socket that happened to be 55MM in length. There is a lot of force on the subframe, so the spacer must be strong and sit squarely.

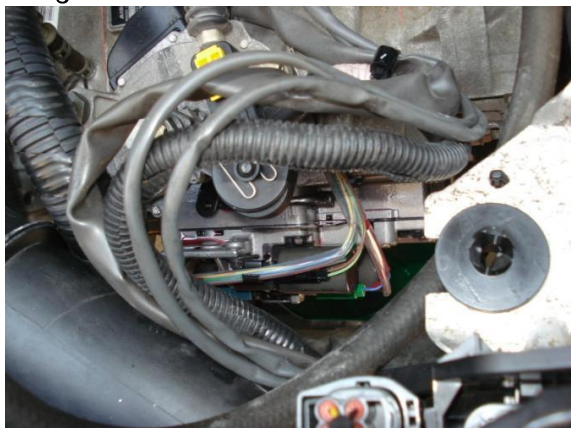
View of valve body from above with cover removed.

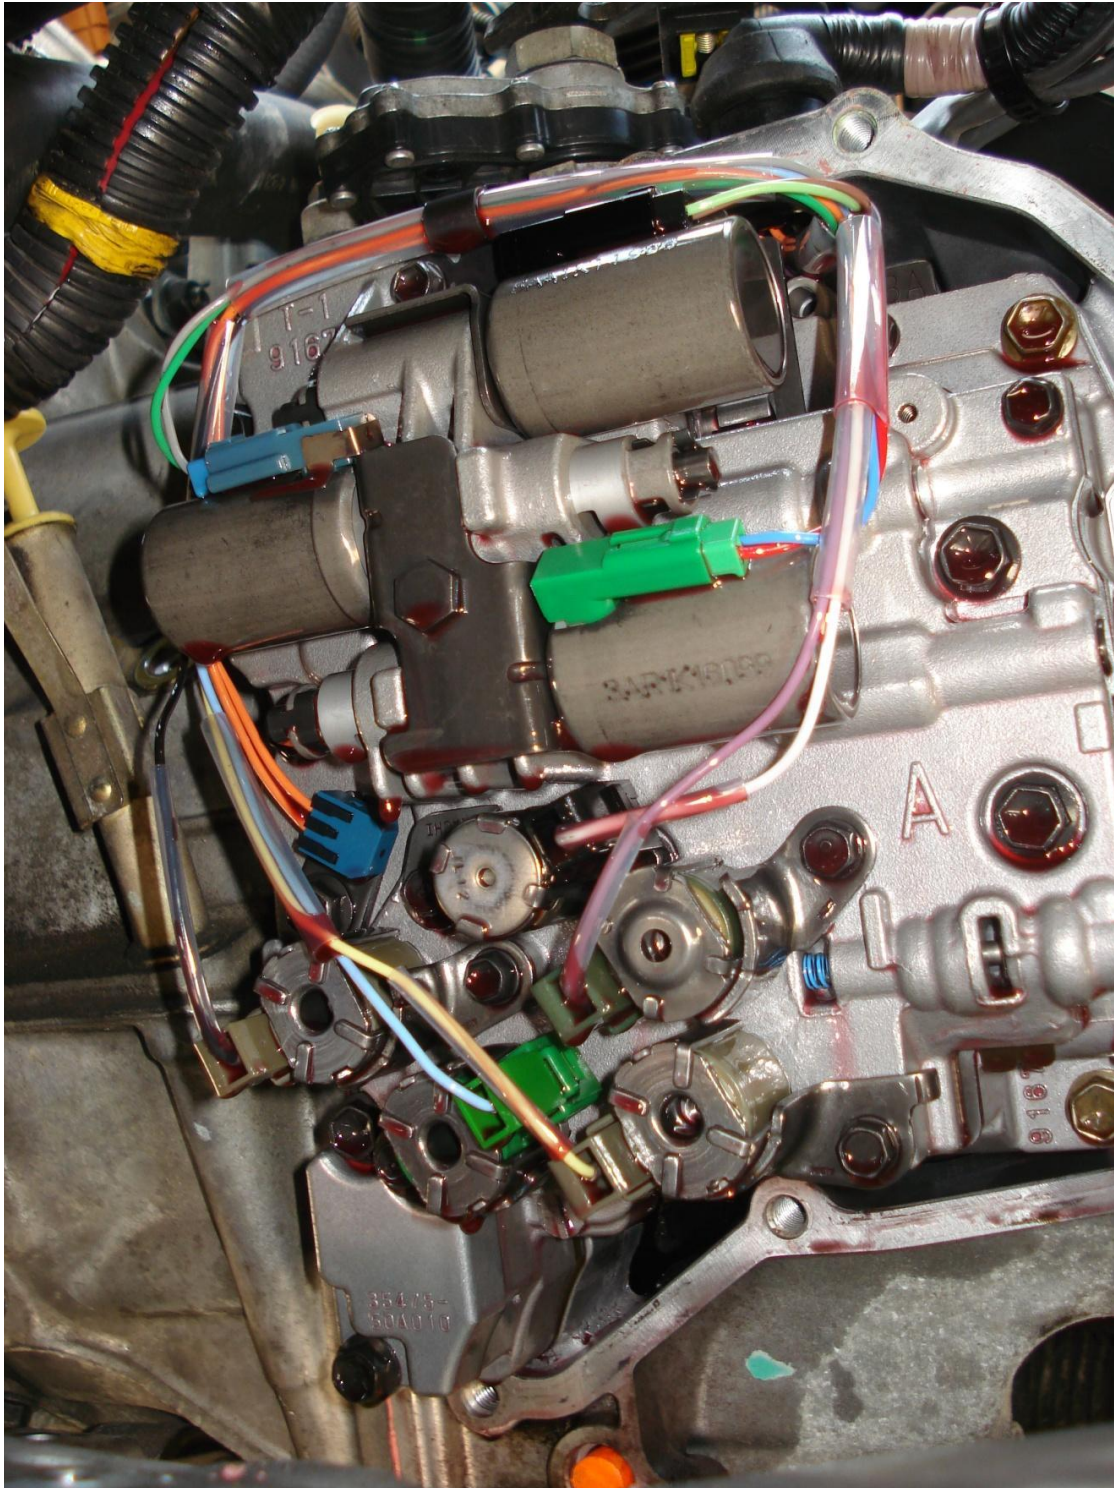
Valve body close up showing wiring and attachment details.

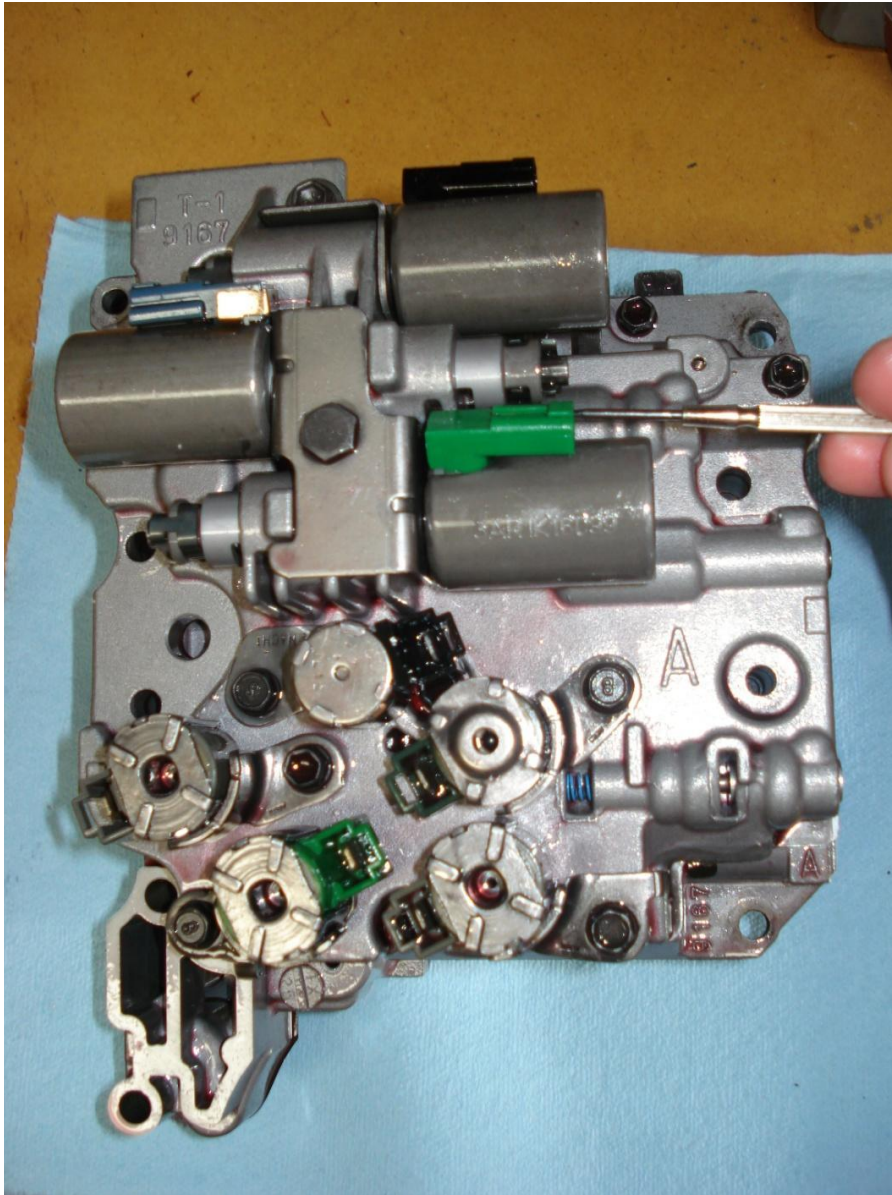
Disconnect the wires for the solenoids. I used a micro screwdriver (5/64") inserted in the connector to release the clip holding the connector to the solenoid. I recommend taking a good digital picture to ensure that the wiring is routed and connected correctly on installation.

Screwdriver shown in position to release clip (valve body on bench)

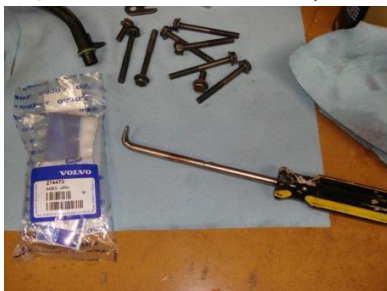
Remove the bolt holding the oil temp sensor (10MM) and remove the sensor and its retaining clip. I used a hook tool (old screwdriver – very useful) to gently pull the sensor.

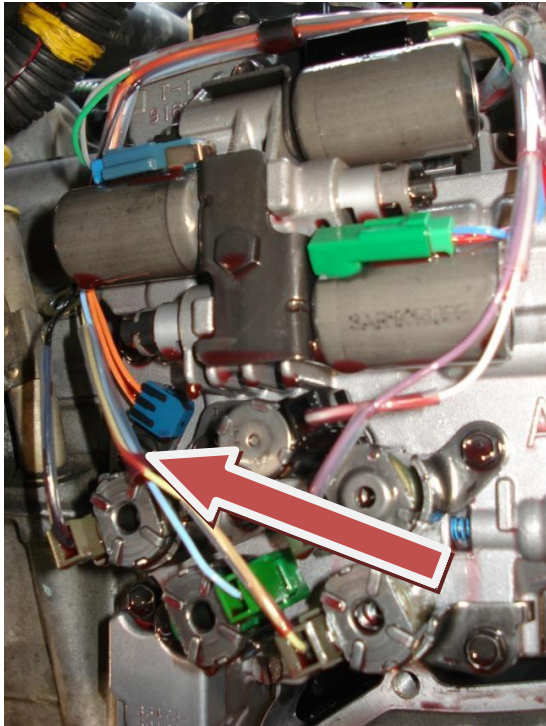
Oil Temp Sensor bolt location (55MM)

Install the Oil Temp Sensor, bracket and bolt (55MM). Tighten to 10NM.

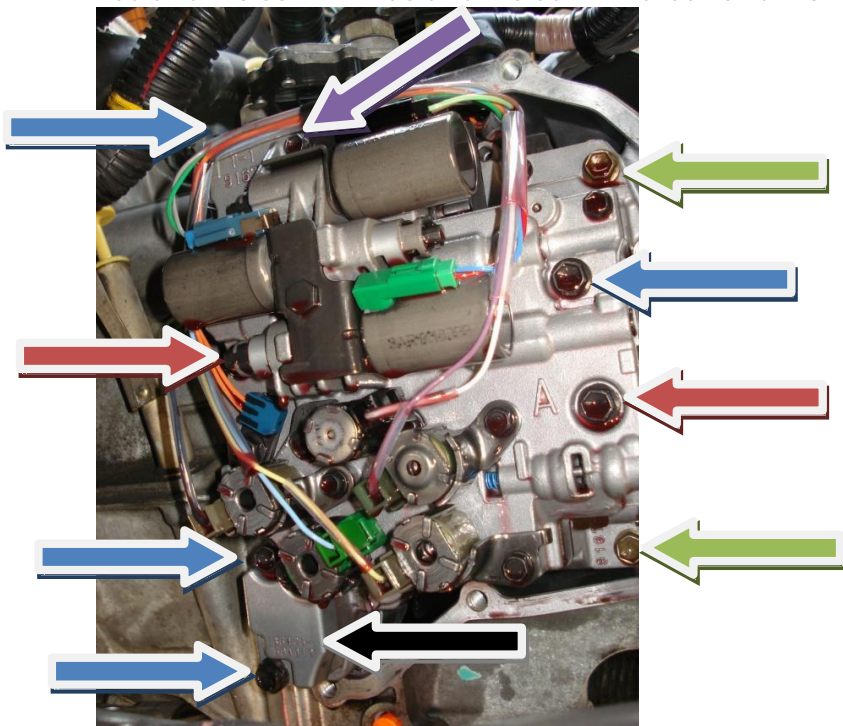
There are 3 lengths of bolts: 55MM, 50MM and 16MM. The sensor bolt is 55MM (shown)  
 Remove the solenoid retaining bracket on the top (8MM bolt – purple arrow) in order to remove wiring harness. Replace bolt. 7NM torque. Remove the 8 bolts remaining in the valve body. Red arrow is 55MM. Blue arrow is 50MM. Green arrow is 16MM.

The cover indicated by the black arrow is separate from the valve body and is held in place by the 2 50MM bolts. Be careful when removing the body that it is not dropped or damaged.

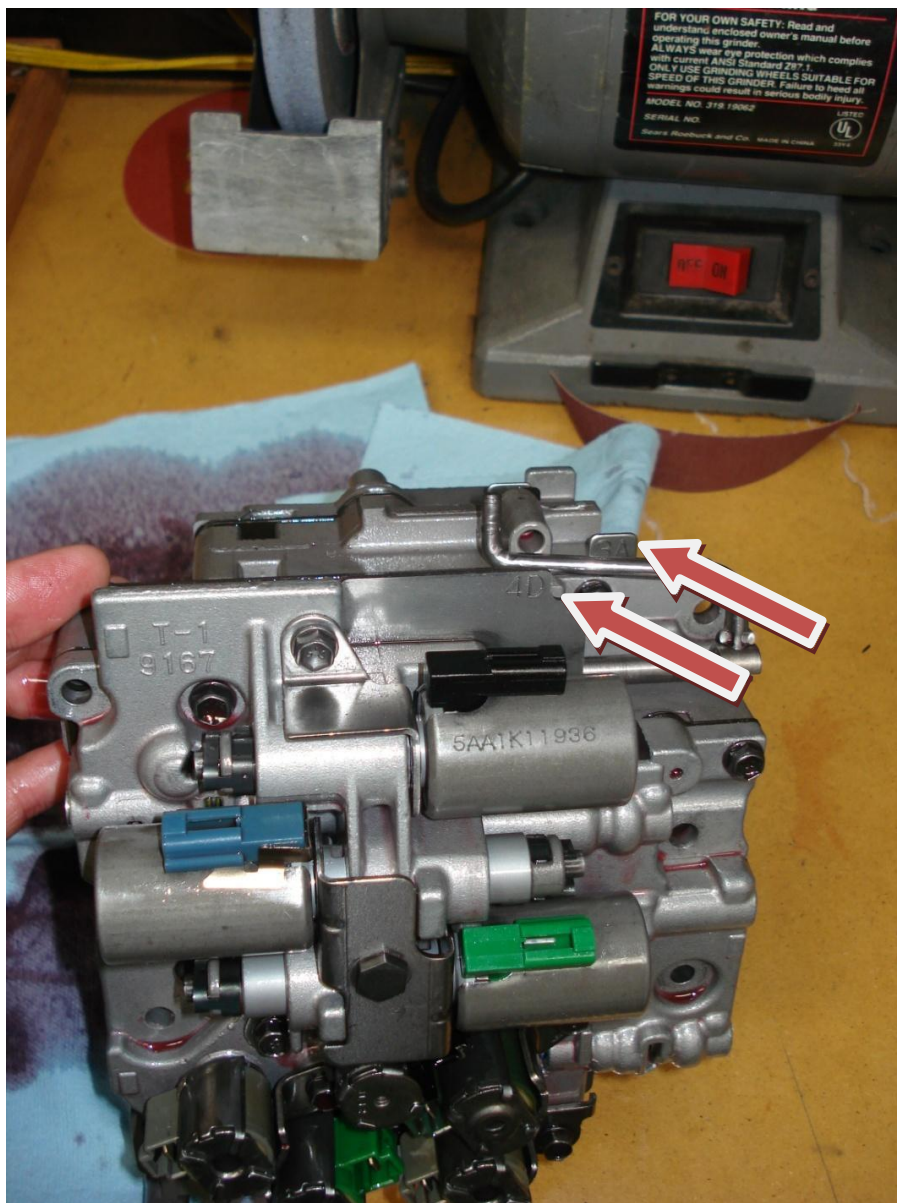
On the bench, the valve body plate codes are visible (red arrows). Due to running changes in the transmission, these plate codes and the type of B5 release valve are needed to accurately replace the body. The Volvo dealer uses the VIN to determine this and they will sell you a new body (called a Transmission Control System) for about \$1400. For Valve Body Builders, they can send one that they have in stock (if you've got the codes and the type of valve) or you can send them your body and have them rebuild it. They finished mine in one day for \$495 CDN. Contact them for shipping details into Canada. Rebuilding takes a day or two, but shipping adds considerably.

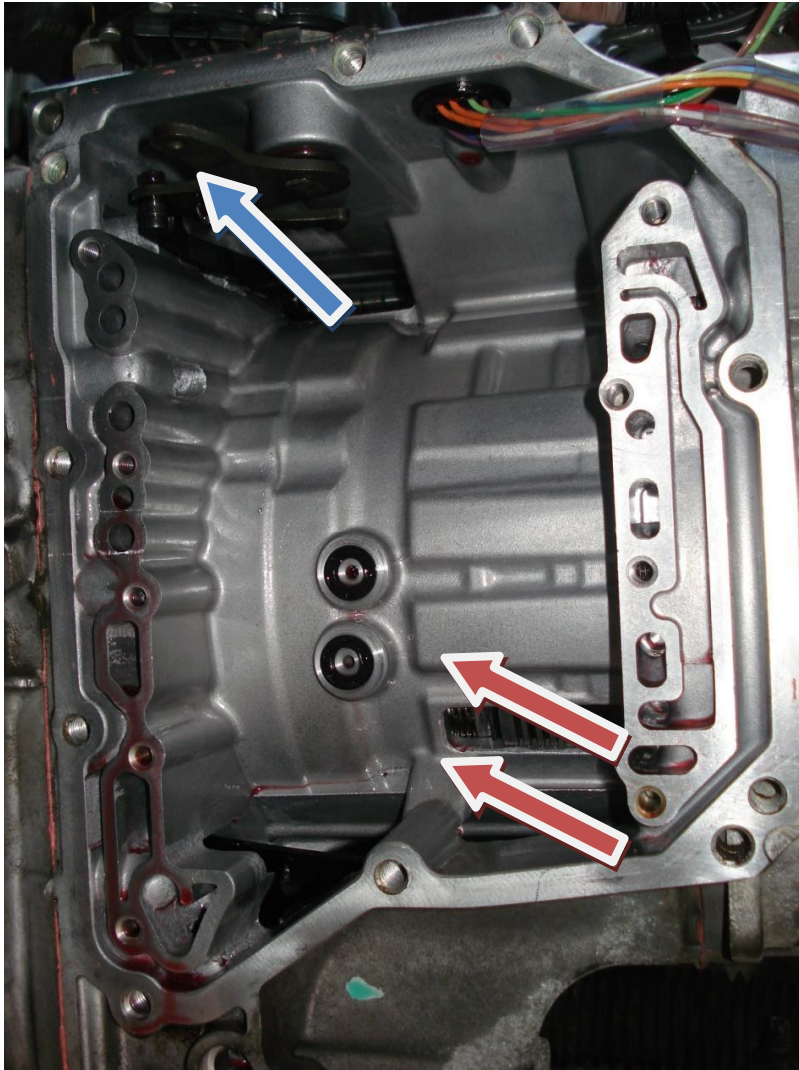
Remove old sealing rings from transmission body.

Sealing rings shown. Also visible in picture are the mating surfaces for the valve body and threaded holes for the mounting bolts.

Install new seals (from Volvo sealing kit) in the transmission. Use petroleum jelly to hold the seals in position while valve body is installed.

Check that the lever for the gear selector slider (L-shaped sliding lever on top) is correctly positioned to engage the hole in the gear selector shown by the blue arrow above.

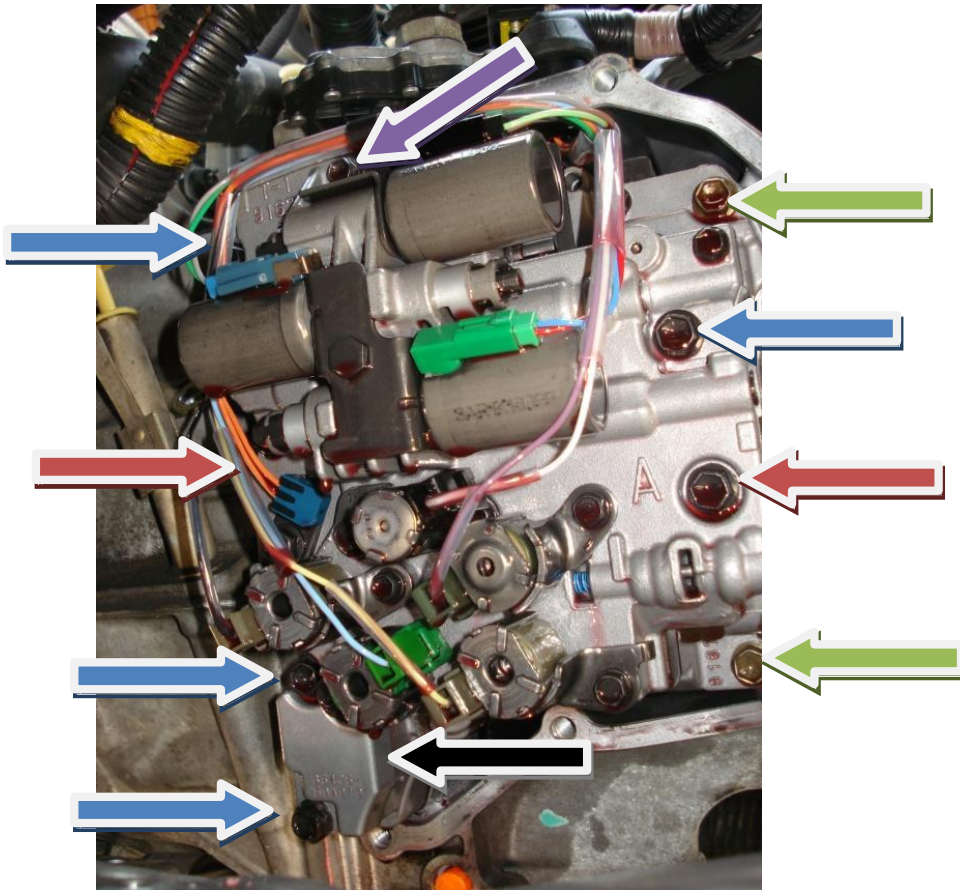
Align the valve body on the gear selector lever. Install the bolts, noting the correct length for each bolt. Install a new gasket for the small cover on the lower left (from Volvo Sealing kit). Tighten each bolt by hand, then gently tighten alternately. Tighten all to 10NM.

Red arrow is 55MM. Blue arrow is 50MM. Green arrow is 16MM.

Remove the solenoid retaining bracket on the top (8MM bolt – purple arrow) in order to reinstall wiring harness bracket. Replace bolt. 7NM torque.

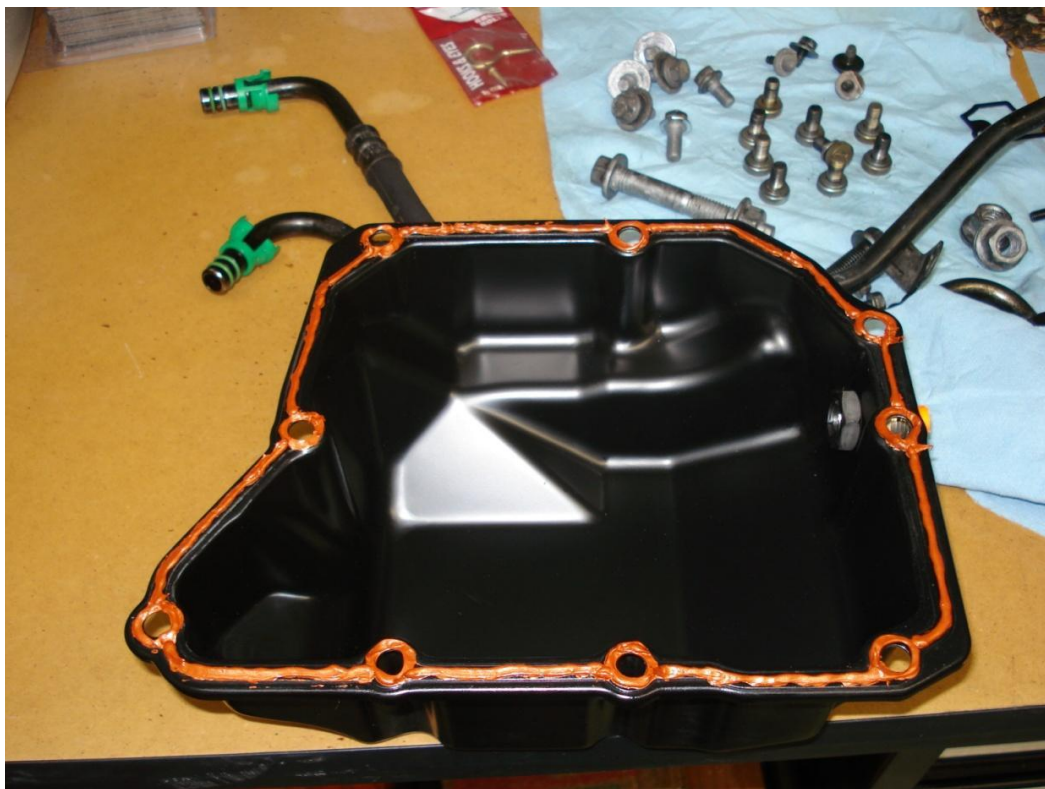
Check that the mating surface and the inside of the cover are completely clean. Apply a 1/8" bead of RTV silicone (best quality you can find to preclude leaks) to the mating surface, going around each bolt hole completely.

Install new o-rings and clamps on oil cooler line and oil cooler return line.

Gasket material shown on cover along with new o-rings and clamps on lines. Note the cleanliness of the cover.
