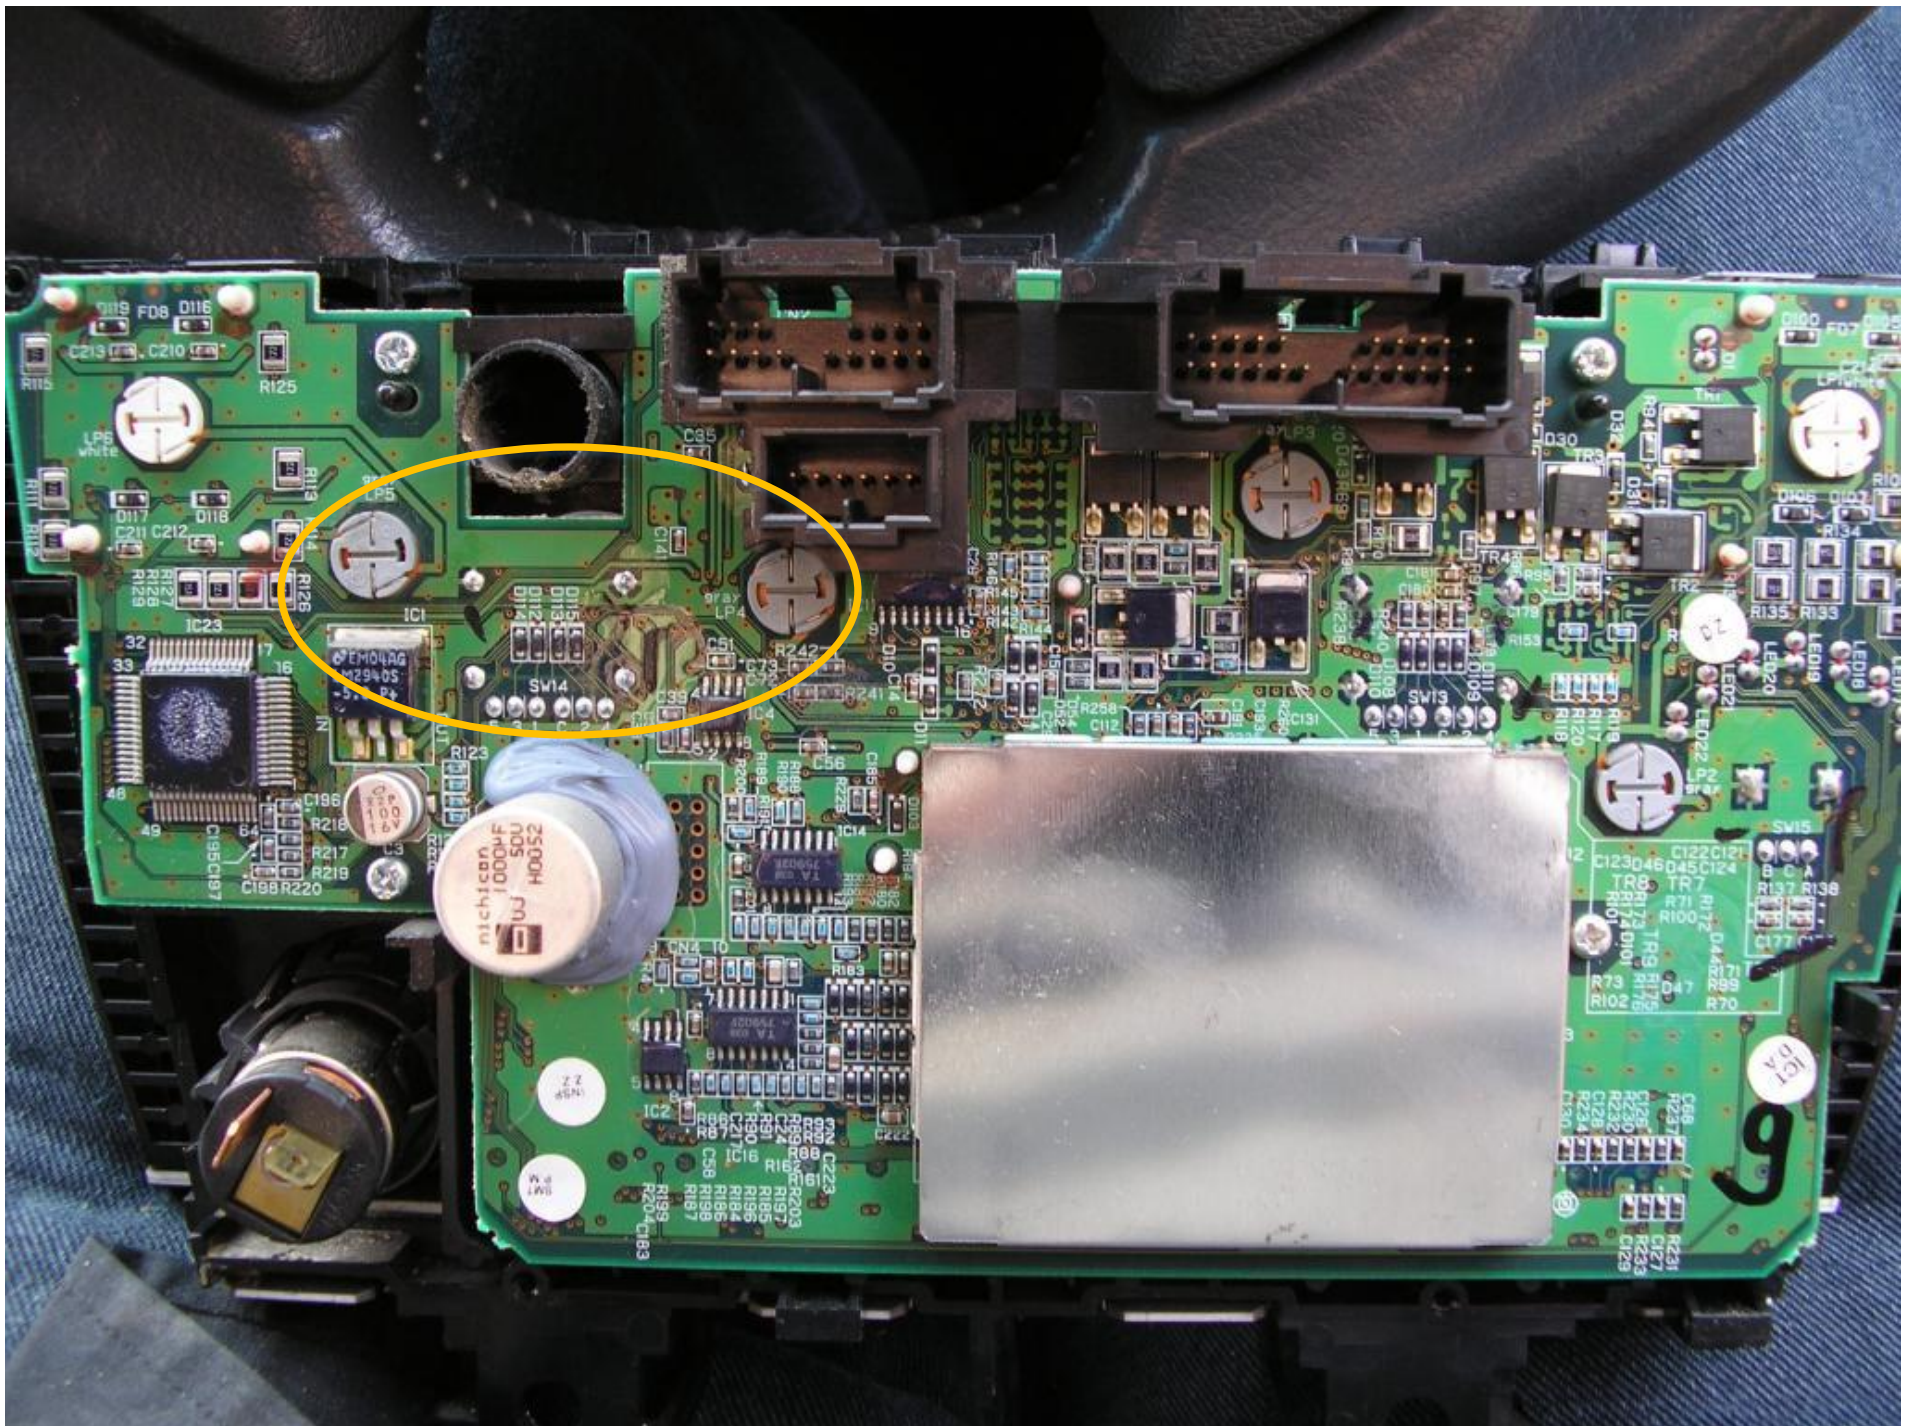
Front, rear  
defrost

Passenger  
side temp  
dial

Power

Ground

Center vent  
control  
lighting

Driver's  
side temp  
dial

Recirculation

Fan speed
