**882: Interior equipment**

C70 (06-), 2009, B5254T7, AW55-50/51SN, L.H.D

88232-2

**Center console**

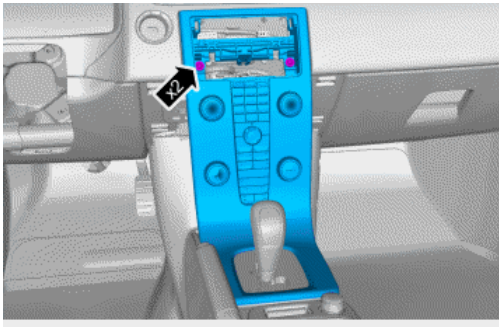
Remove the centre console screw underneath.

Refer to: Tightening torque
