I had a light switch module (LSM) problem where the instruments back lighting went dim and I couldn't adjust them in addition to all the other LSM functions not working, high beam wouldn't stay on, couldn't turn on fog lights, knob for headlights and parking lights didn't function but if I put some pressure on the instrument lighting wheel things would started to work. Because I could get things to work with pressure on the lighting adjustment wheel the problem was most likely a bad solder joint and could be repaired.

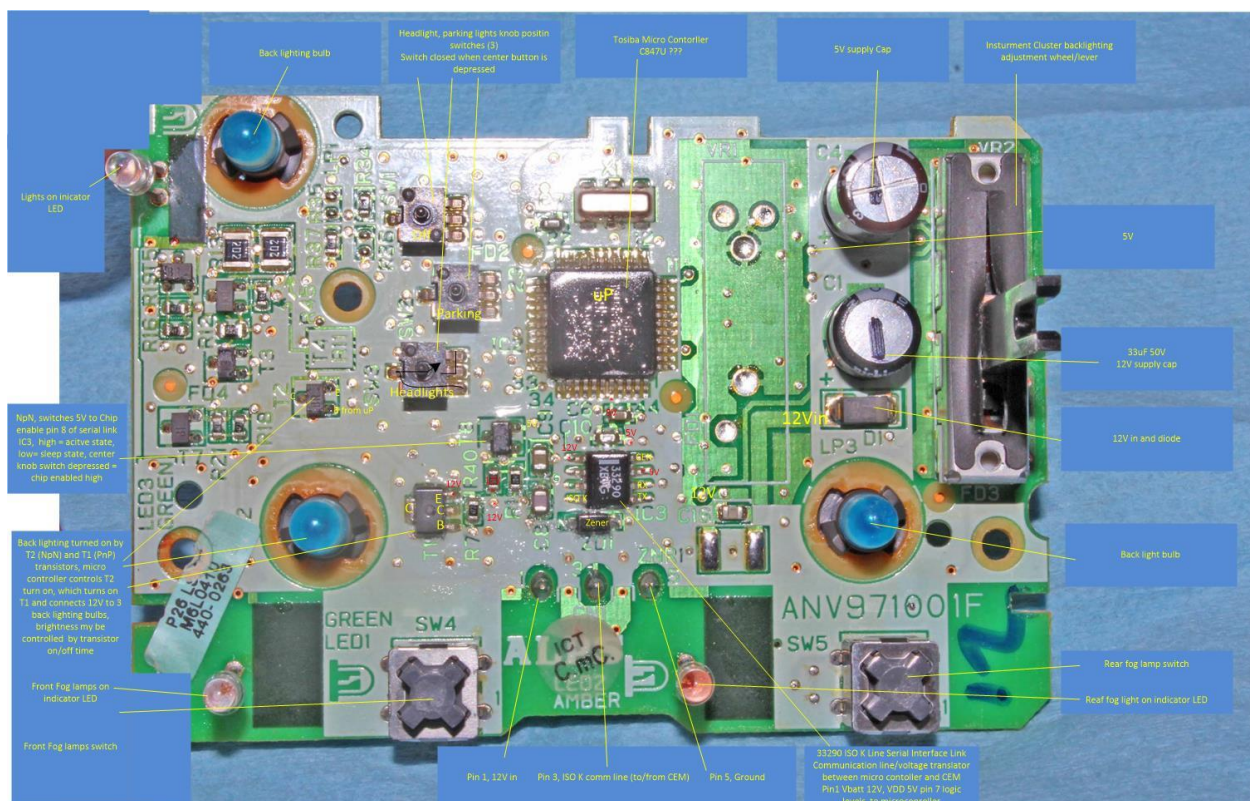
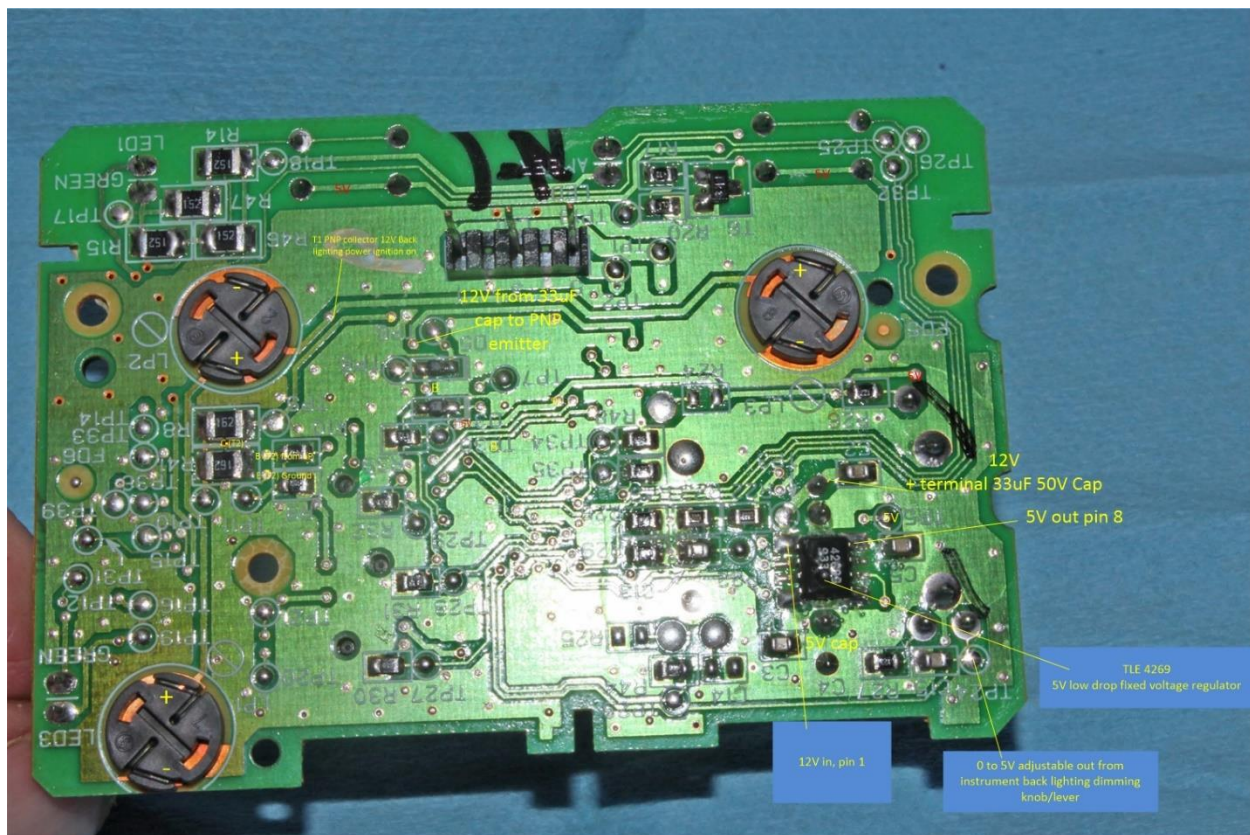
I originally tried to troubleshoot the problem to find the bad solder joint so I took notes on components location and test points, especially the 12V and 5V power supply paths. This is the board before reflowing the solder and replacing the 3 bulbs with LED's and I did mark the +/- bulb sockets for correct LED orientation.

There's a Youtube video and a pdf available showing an area of the LSM circuit board where you should reflow the solder joints but in my case this didn't help. I ended up reflowing solder on just about every solder joint and device pin connection on the circuit board including the 44 pin microcontroller IC. I saved the 44 pin IC for last because of the close pin spacing and the risk of totally screwing things up but reflowing the solder on these pins seems to have fixed the circuit board. I did carefully (with magnification) look at all the solder joints before hand and didn't see any problems but could flex the board and get things to work so it had to be a bad solder joint somewhere.
